## Lake Manitou Dam, 190 Years, History

PROJECT No. E06-0068

LAKE MANITOU - OUTLET STRUCTURE AND DAM REPAIR

# Lake Manitou Dam and Spillway Upgrade

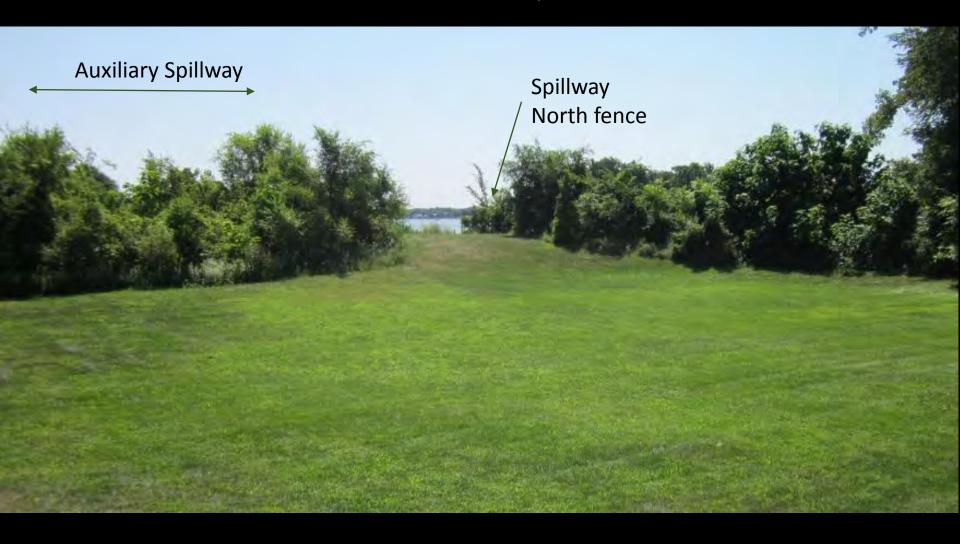
### 2015 Brush Clearing

### North Embankment, Before

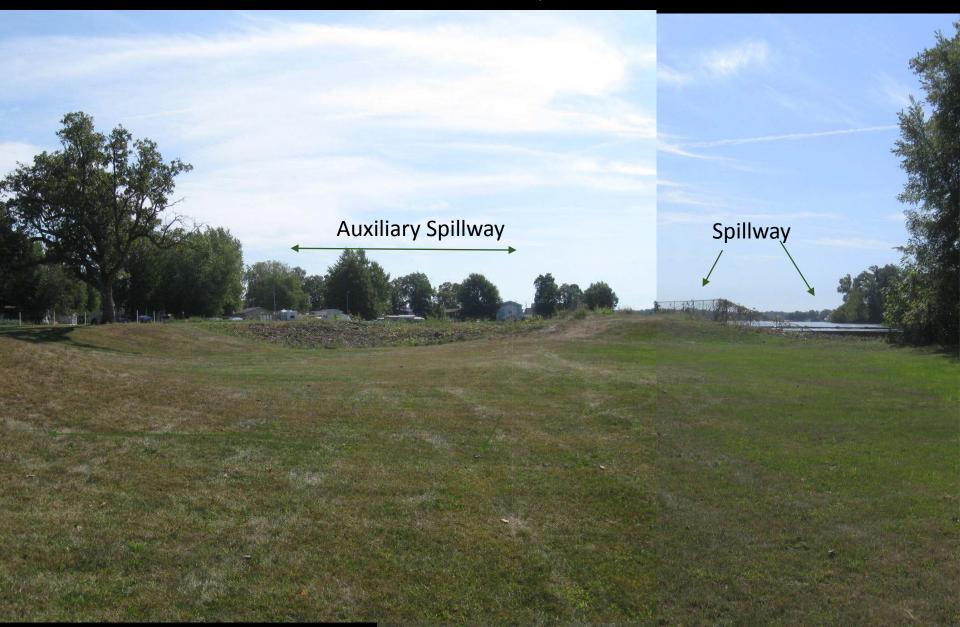
### 2015 Brush Clearing

North Embankment, After

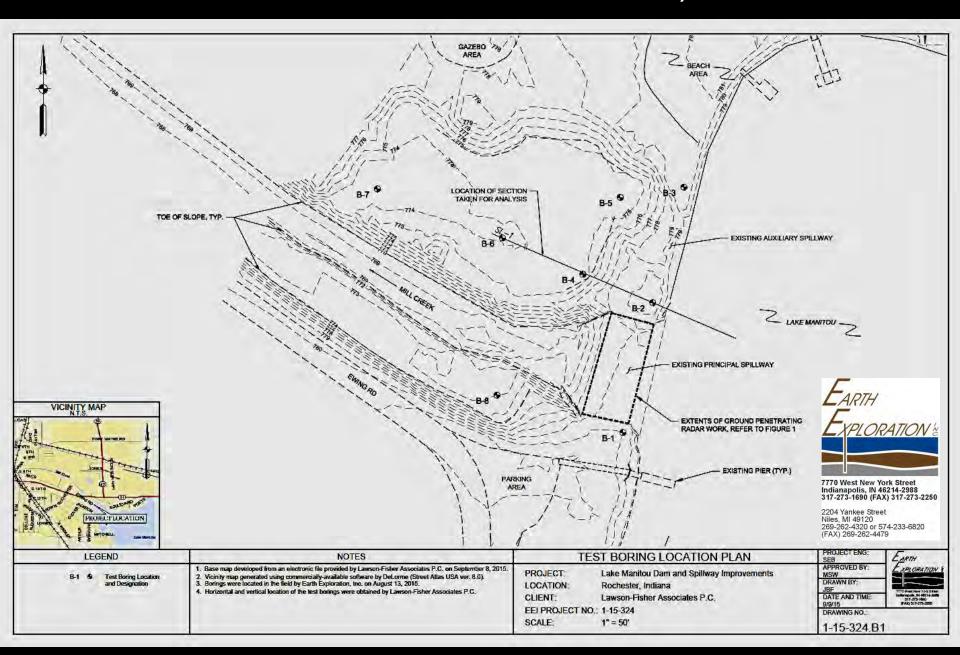
## Geotechnical Evaluation, 2015

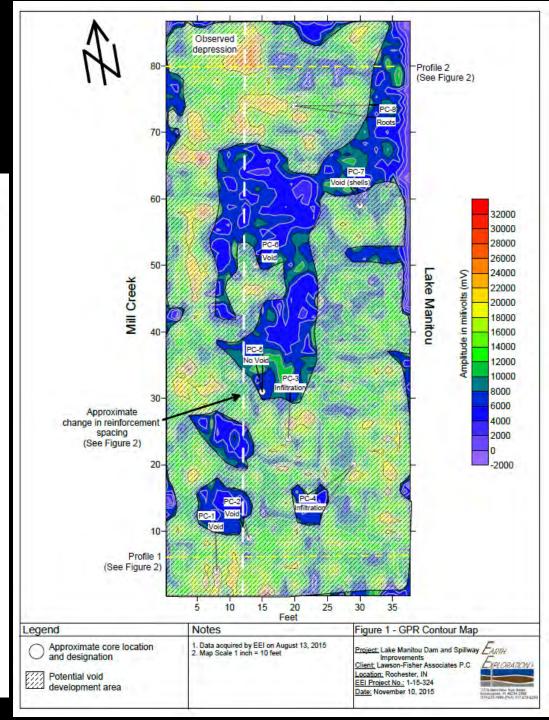
#### SUMMARY OF CONCRETE CORES

Cor	e Designation, Location and Description (in.)	Photograph				
0-8¼ 8¼-	PC-5 Portland Cement Concrete Sandy gravel with cobbles near 12 in.	201 2 3 4 5 6 7 8 9 10 11  EEP Project No. 1-5-525  Lake Mantes Sprillway Rocknown, III  Cole No. 195 8  OF 15 2015				
0-9½ 9½ -11 11-	PC-6  Portland Cement Concrete with 0.5 in. diameter rebar at 7 in. Void Sandy gravel	EFF Process in 1-10-024 Later National Stationary Alechanists, St. Core No PC-6  00, 11, 2015

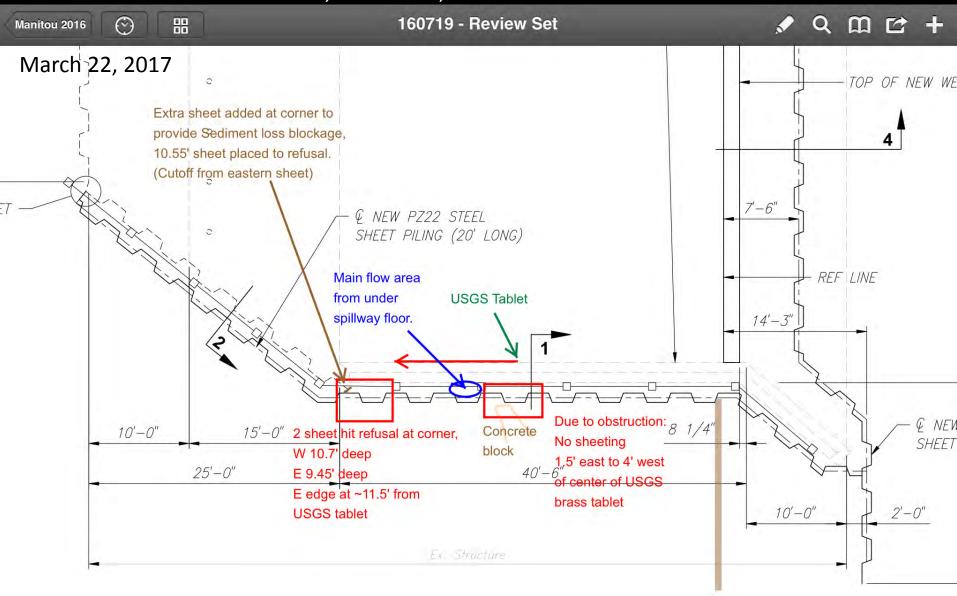
OUTLET STRUCTURE

### **Unknown History Can Change Plans**

Decide, Document, and Move On

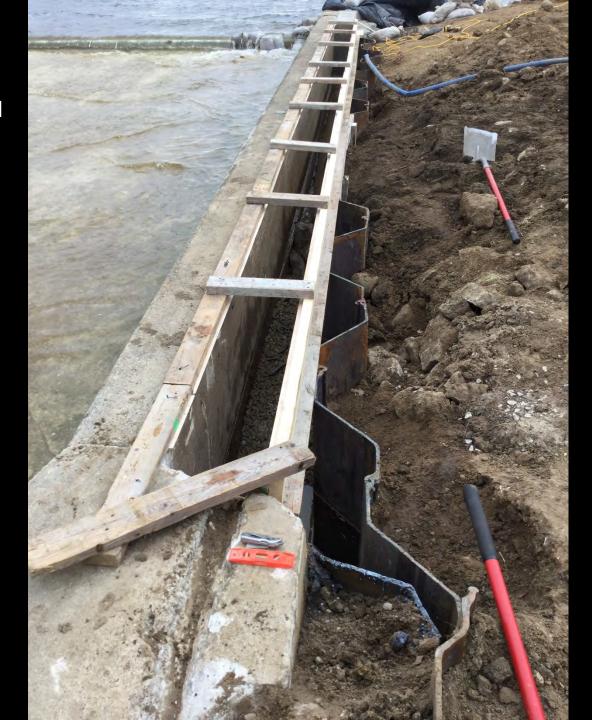
March 23, 2017

South Wall Steel
Sheet Piling
Complete

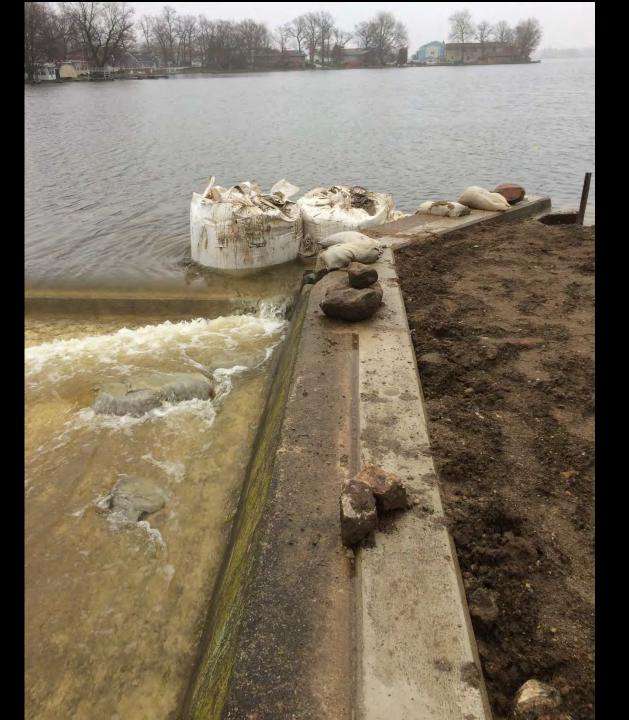
March 31, 2017

South Wall Complete

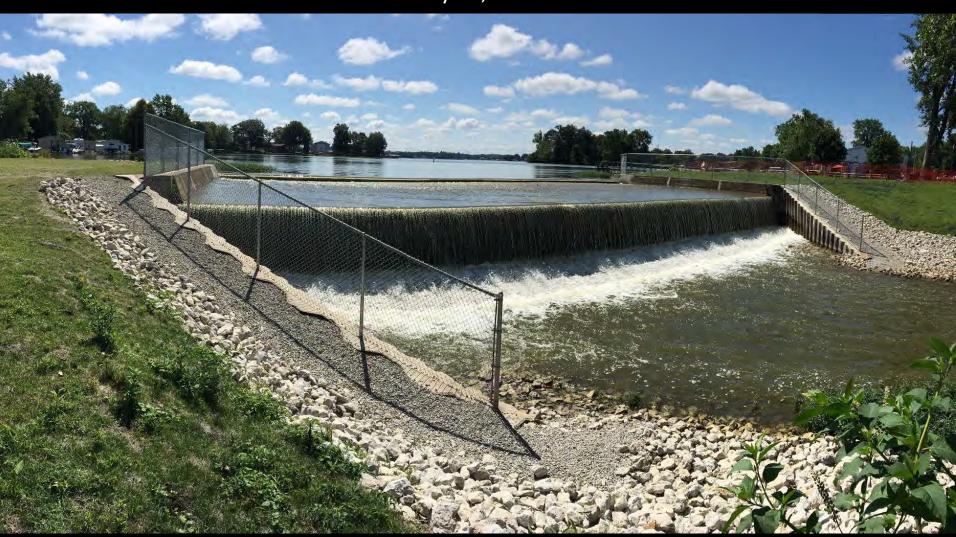
Spillway Complete (panoramic) July 15, 2017
