Inspection, Enforcement and Maintenance of Post Construction BMPs: A Public Utility's Perspective

*2018 INAFSM Annual Conference
November 7, 2018*

Presenter: Craig Frye

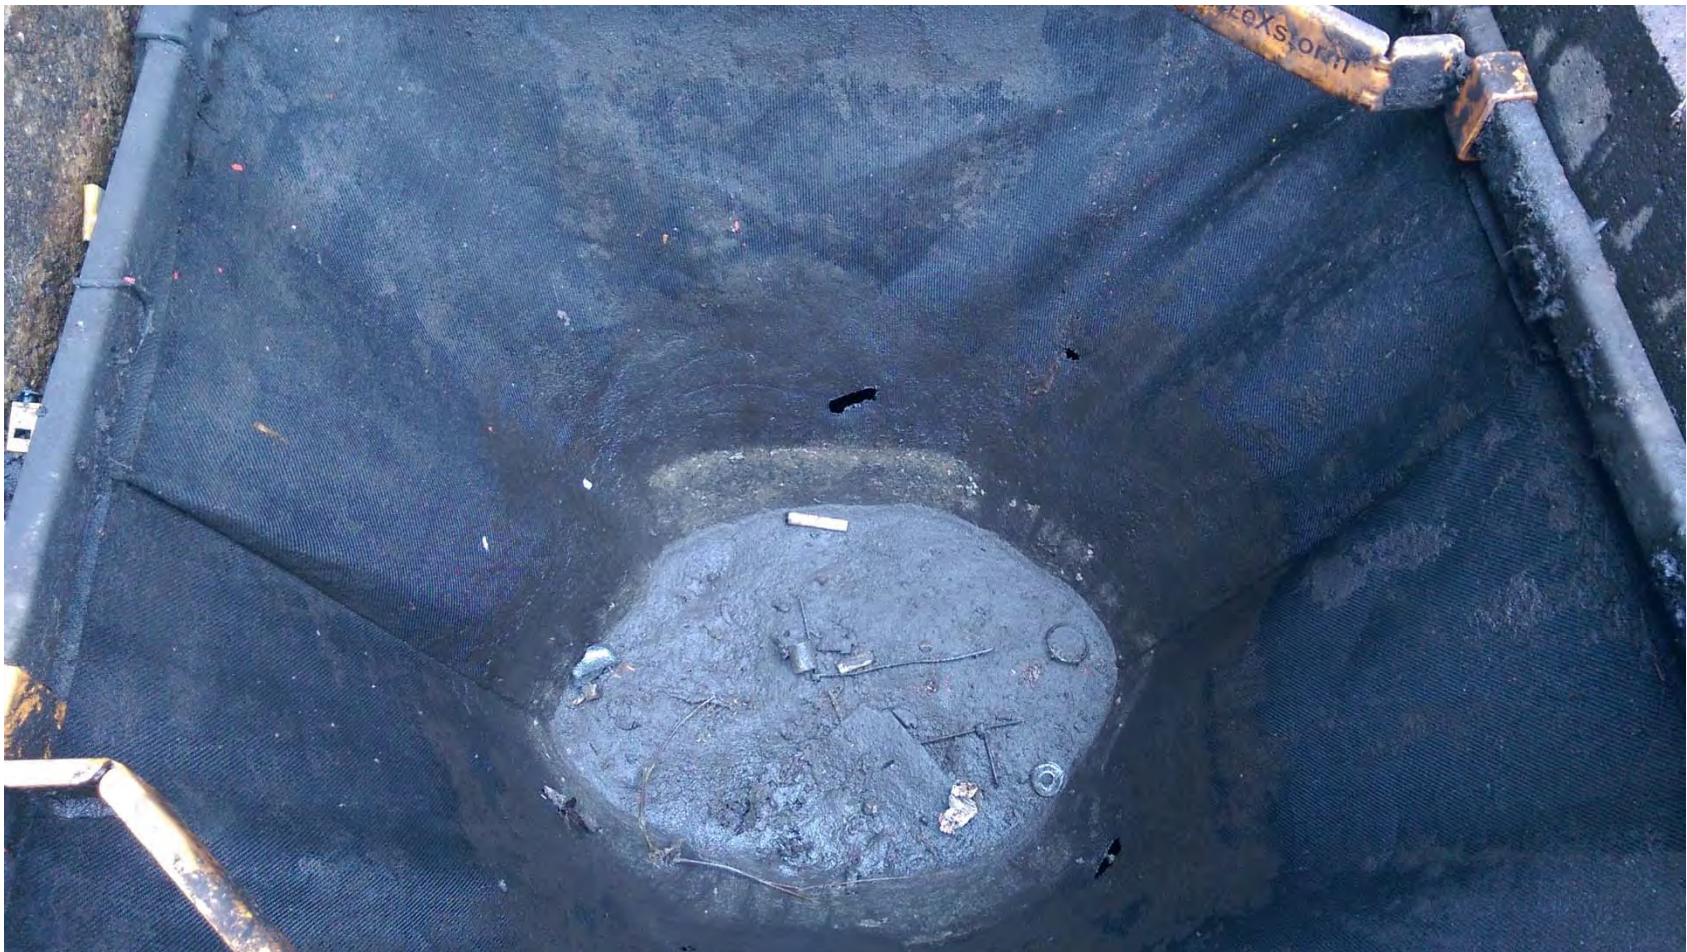
Manufactured Device

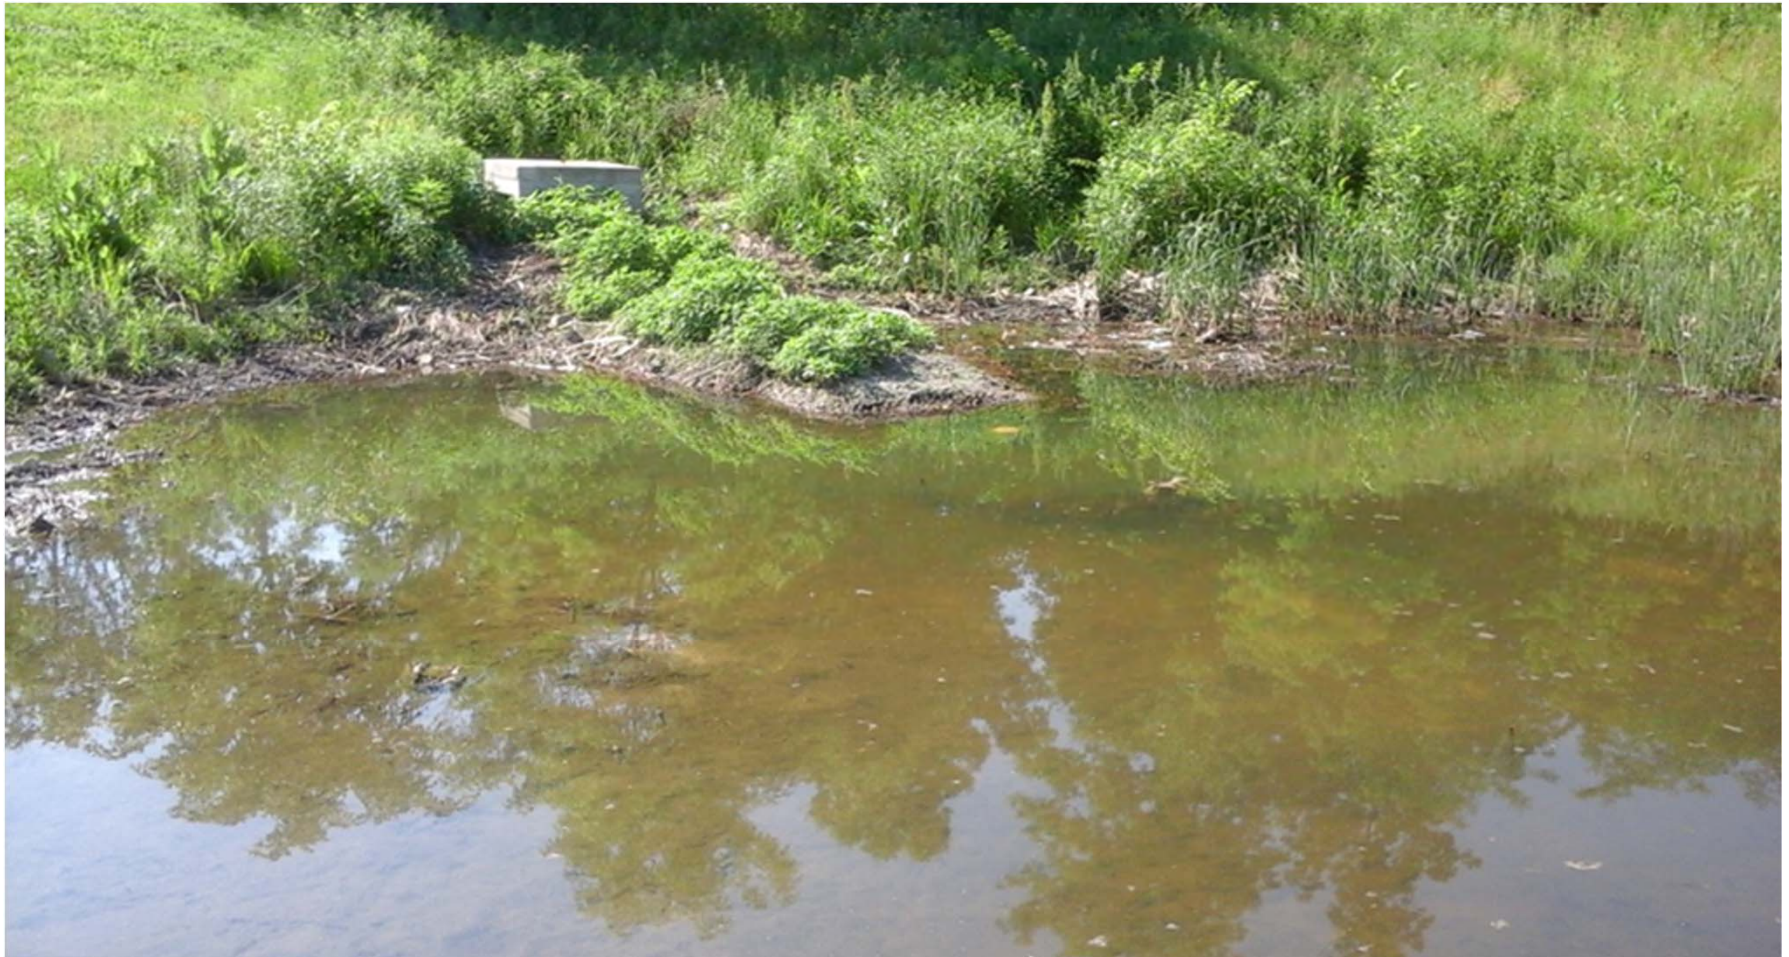
Sediment Accumulation Extended Detention

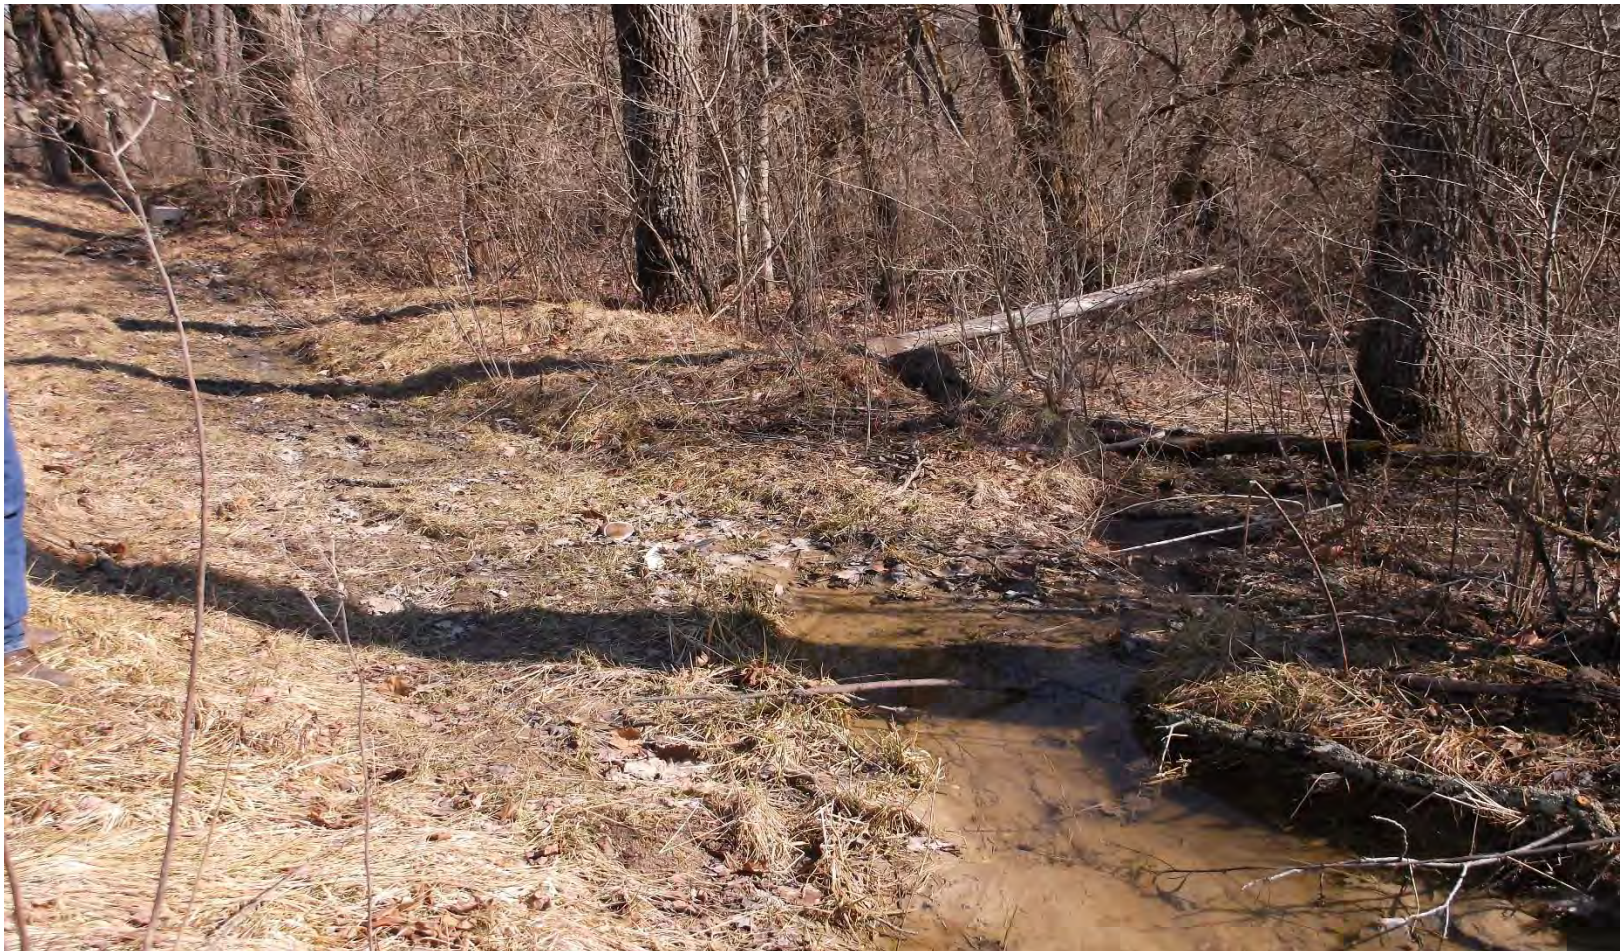
Berm Failure Bioswale

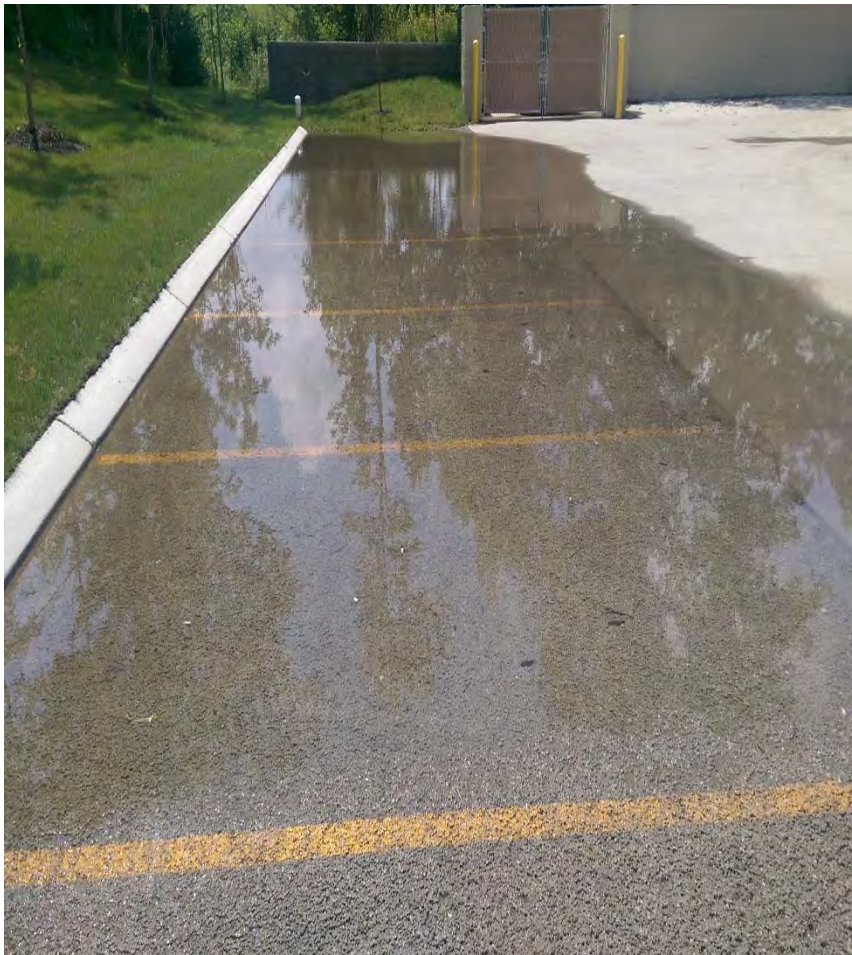
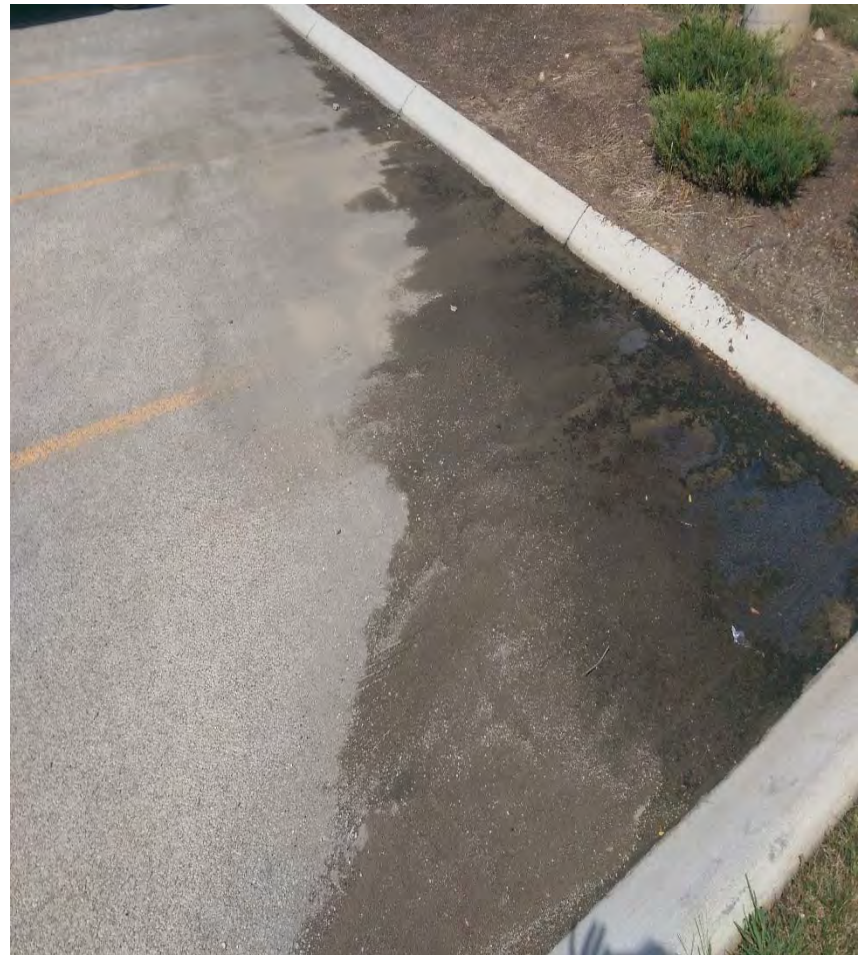
Sediment Accumulation Permeable Concrete

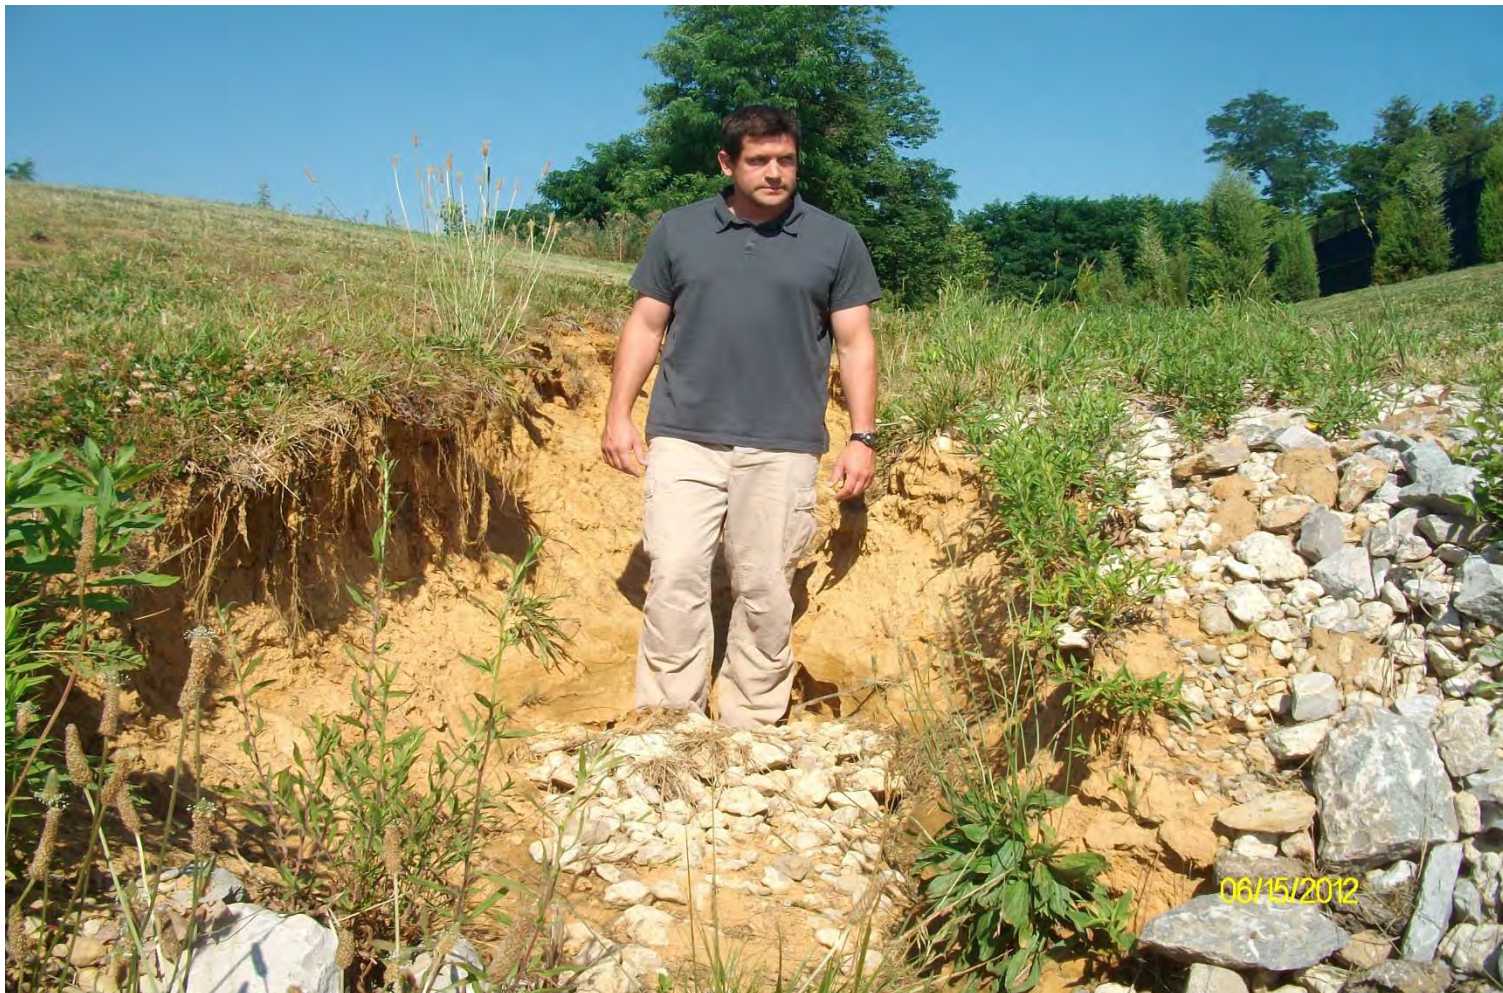
Erosion Bioretention Basin

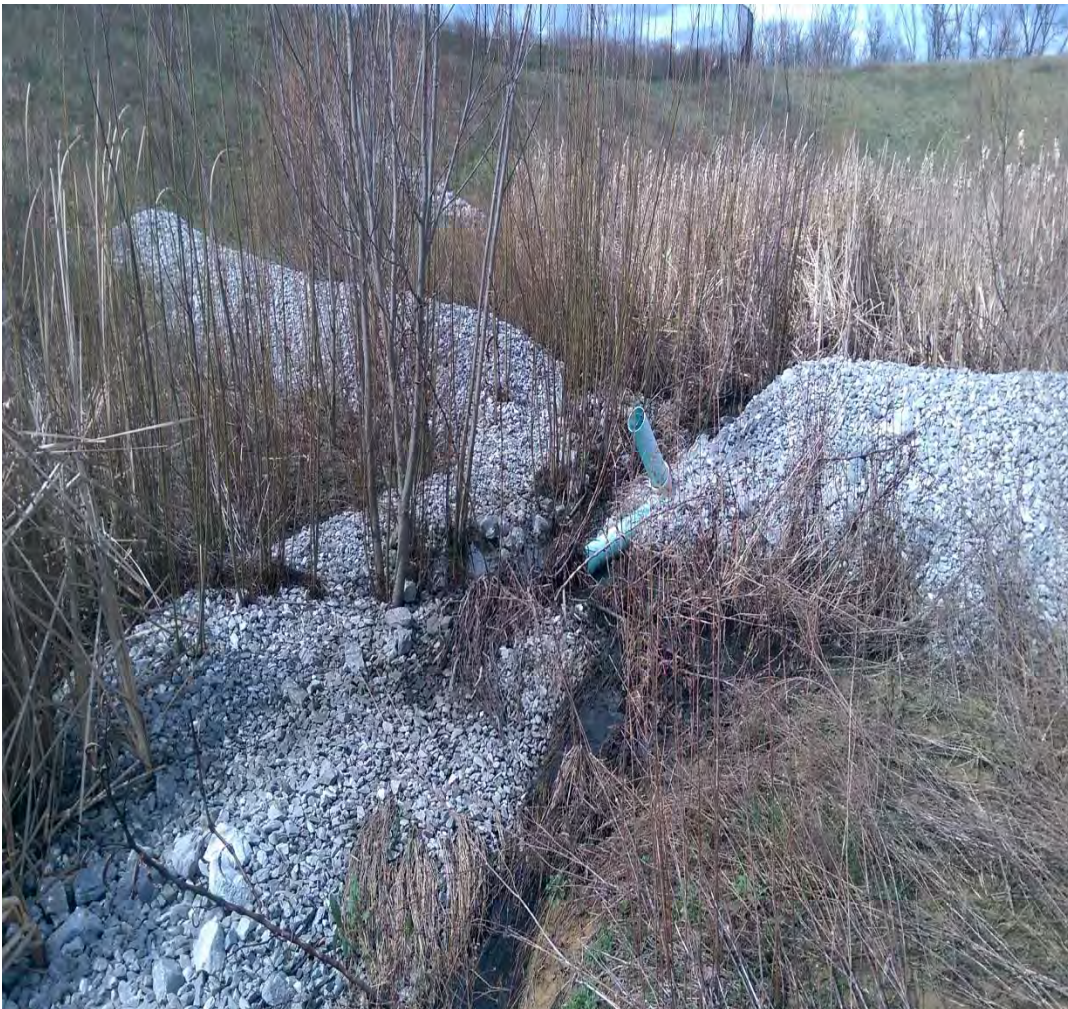
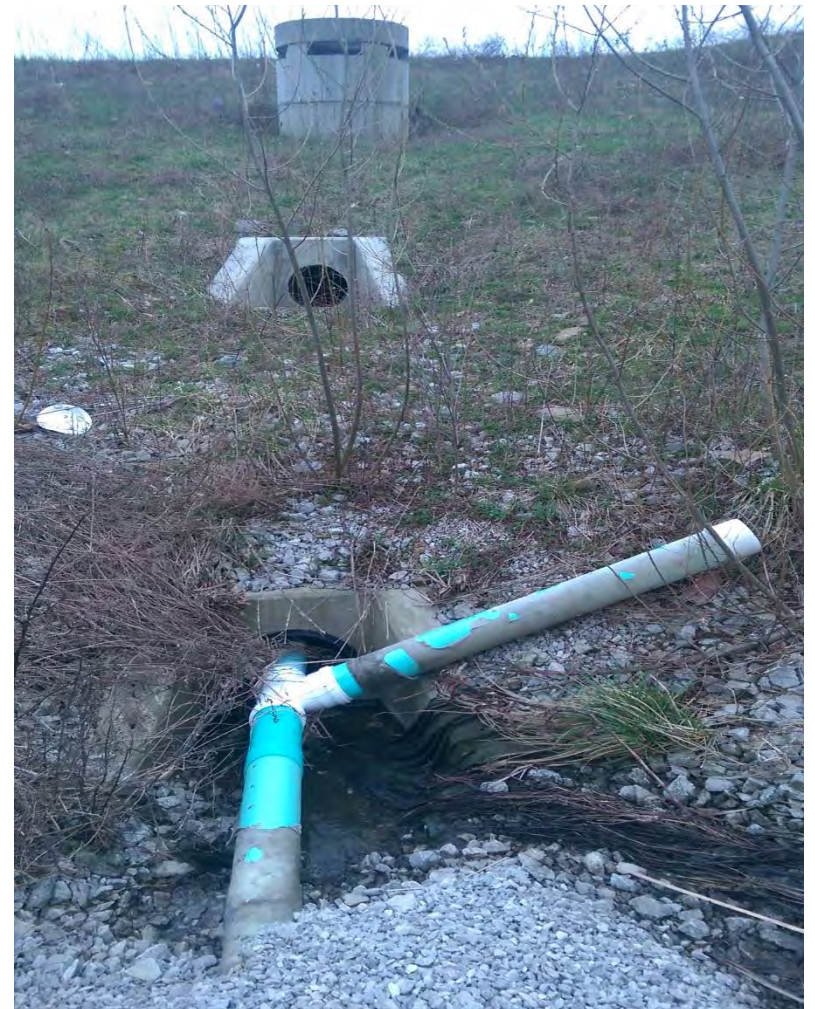
Failed Water Quality Features
