Designer and Reviewer Roles and Importance in Stormwater Management: A Case Study

Walnut Commons

500 N. Walnut Street
Muncie, Indiana

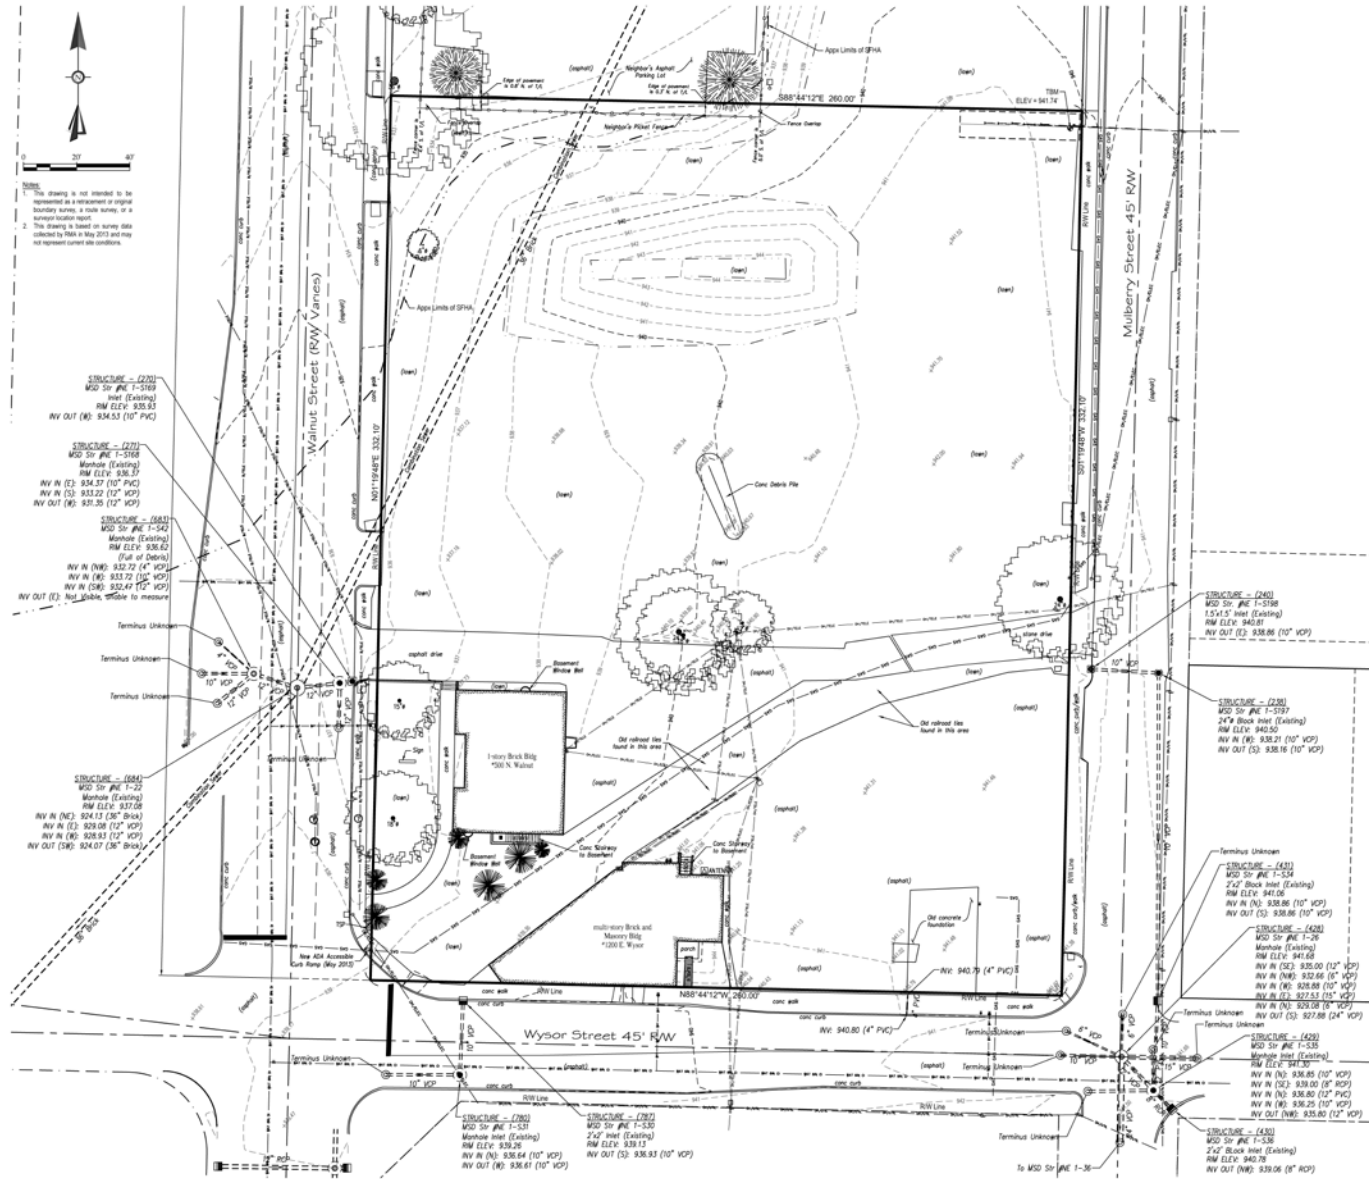
- Proposed Detention Area on “High” side of the site
 - Reverse grading of site
 - Storm Sewer HGL
 - Retention/Detention basin must be deep
- Fill Site
 - Former Armory Building
 - Demolished and filled in on itself
 - Unsuitable subgrade (soils, materials)?
- No Stormwater Outlet
 - Site surrounded by CSO
 - No direct outlet after detention
- Conventional Detention Basin Not Feasible
 - At depth required for site HGL open space left for detention too small to accommodate conventional “pond” with 3:1 or 4:1 sloped banks to get required storage

- Design for Total Retention
 - Green Infrastructure to allow for infiltration
 - No direct outlet available
 - Geotechnical Investigation for subsurface soils
- Design Basin Deep Enough for HGL and to fit in the provided open space
 - Walls
 - Tiered (ledges) for maintenance and safety
 - Aesthetics
- Grading Design for balanced site (earthwork volumes)
 - Site surrounded by CSO
 - No direct outlet after detention

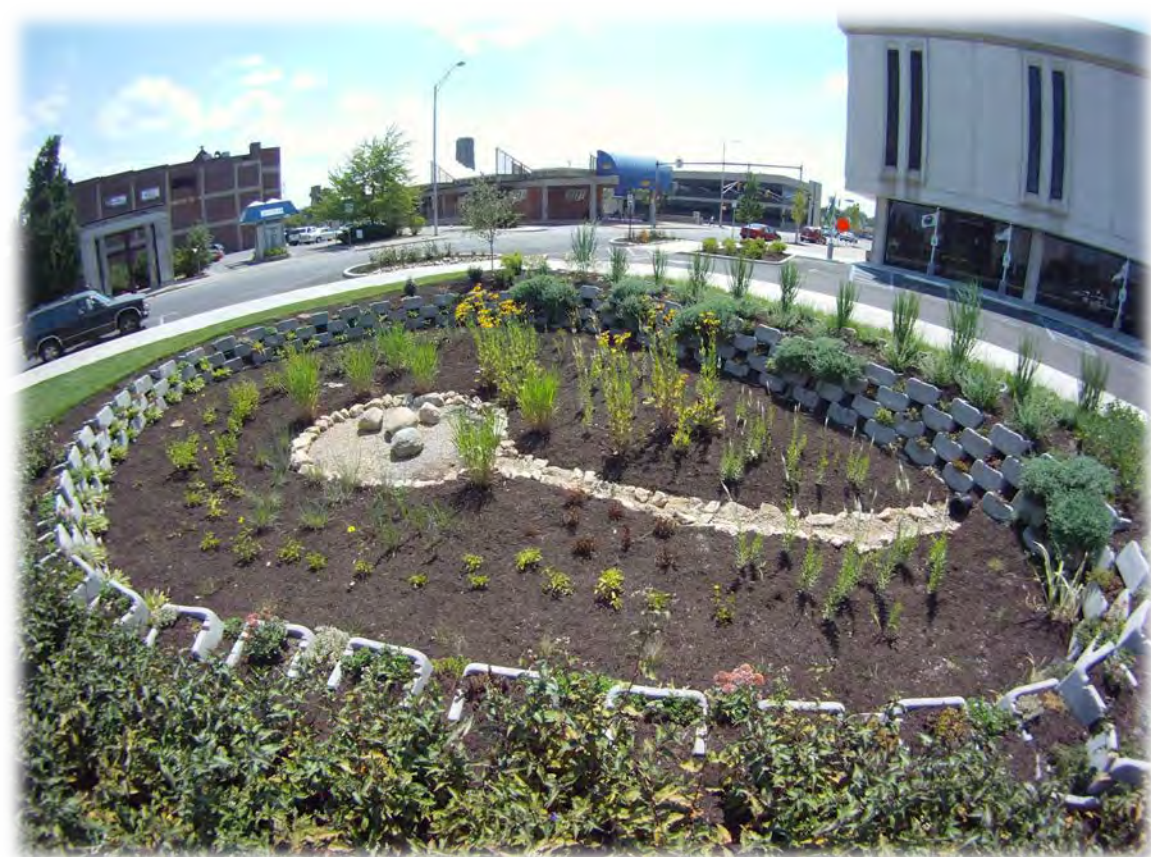
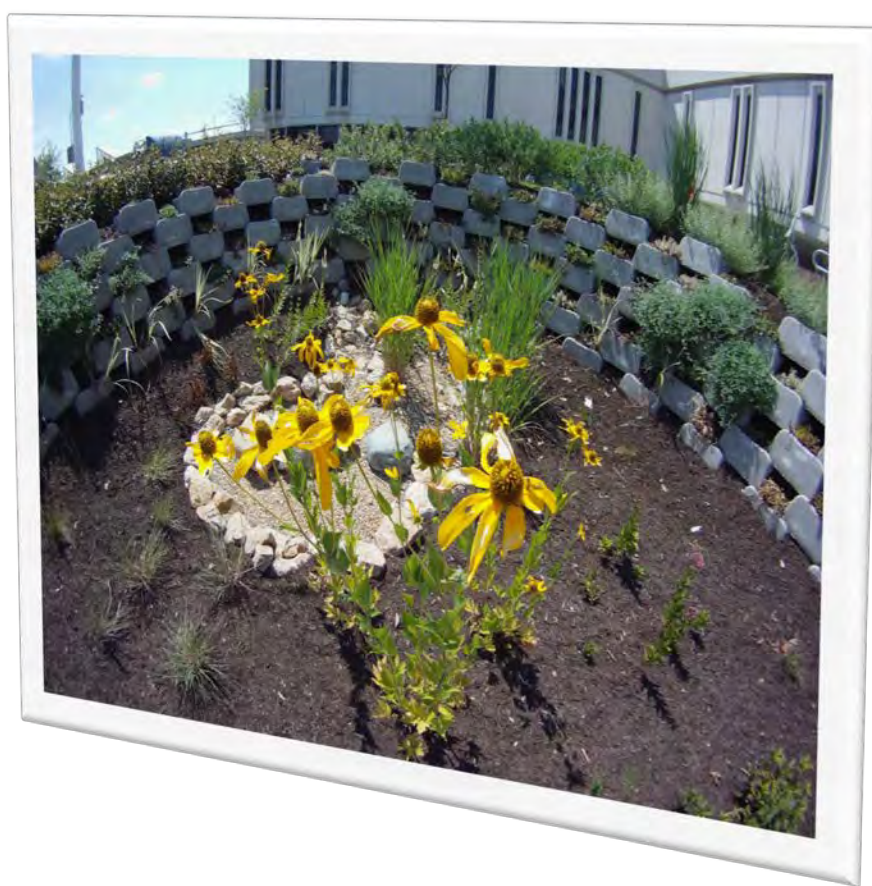
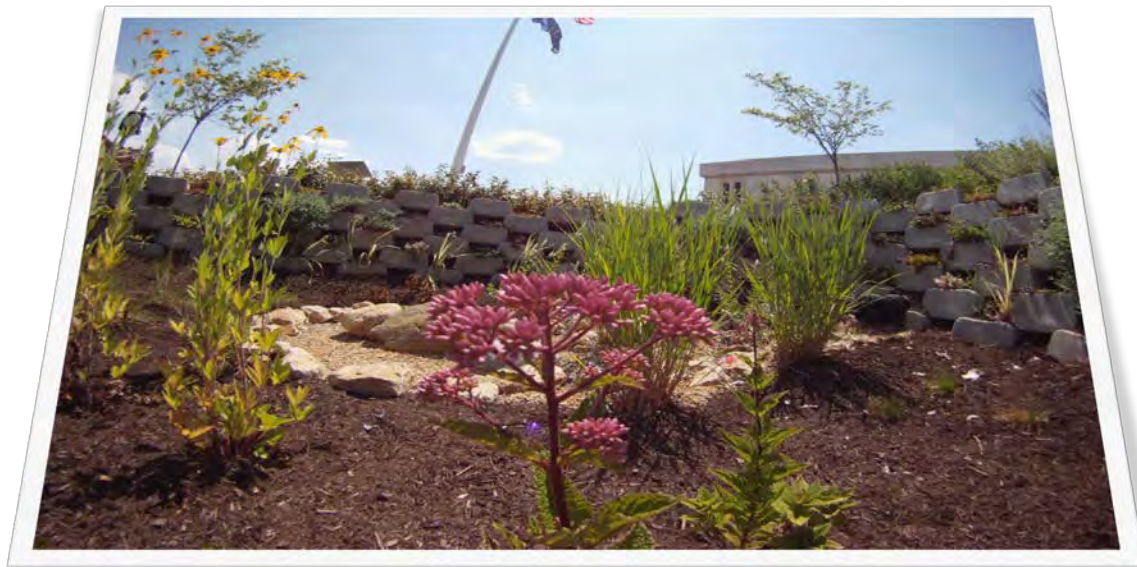
Bioretention Design

- *Aesthetics*

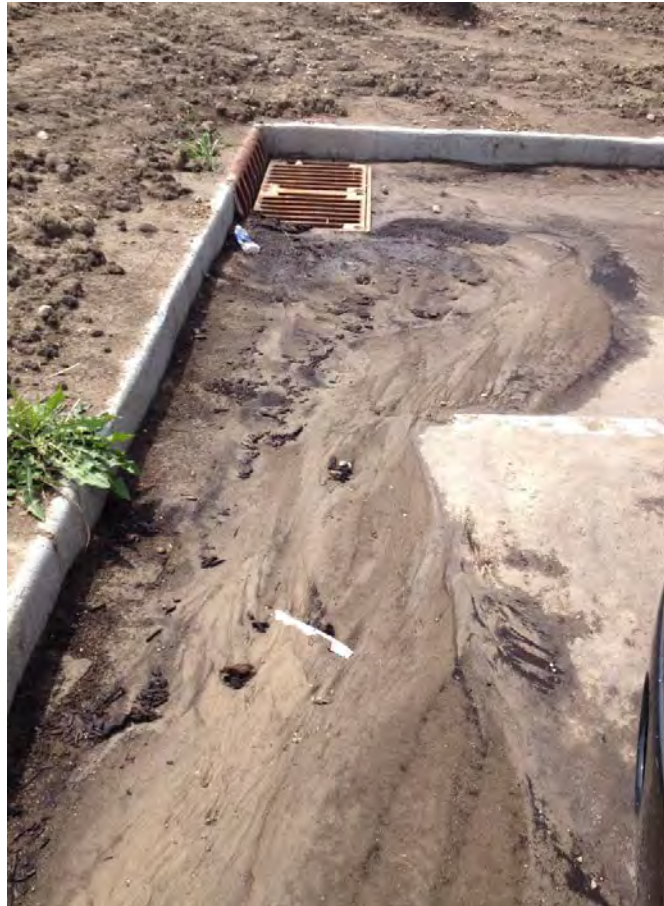
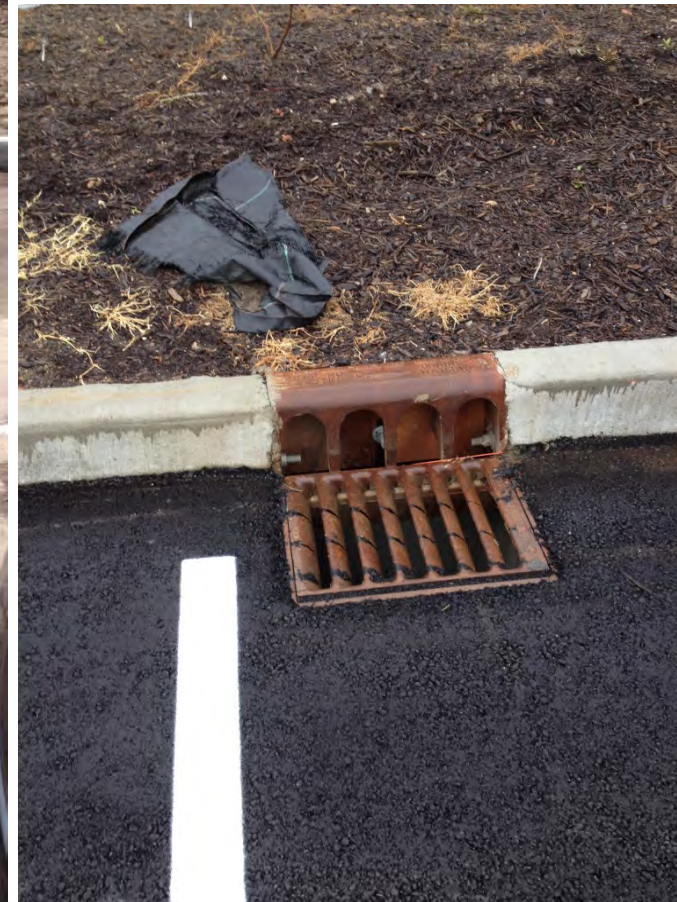
- Series of small independent failures
 - Change in PM between demolition and next phase
 - Interruption in compliance flow
 - Failure to revisit the actual SWPPP to verify practices
 - Specified inlet protection type
 - Grading of a proposed swale on the western side of the building
 - Failure to communicate concerns
 - Failure to communicate that drilling would occur
 - Assumption that the other was watching
 - Overlooking BMP issues due to dry weather
 - Improper inlet protection
 - Failure to properly re-install inlet protection after paving
 - Lack of Bioretention perimeter protection
 - Tolerance of slow corrections on the part of the contractor

- Continuously revisit the SWPPP to verify BMPs
- Communicate concerns when they occur
- Communicate concerns in advance if a problem is foreseen
- Be consistent, require immediate response to any and all violations

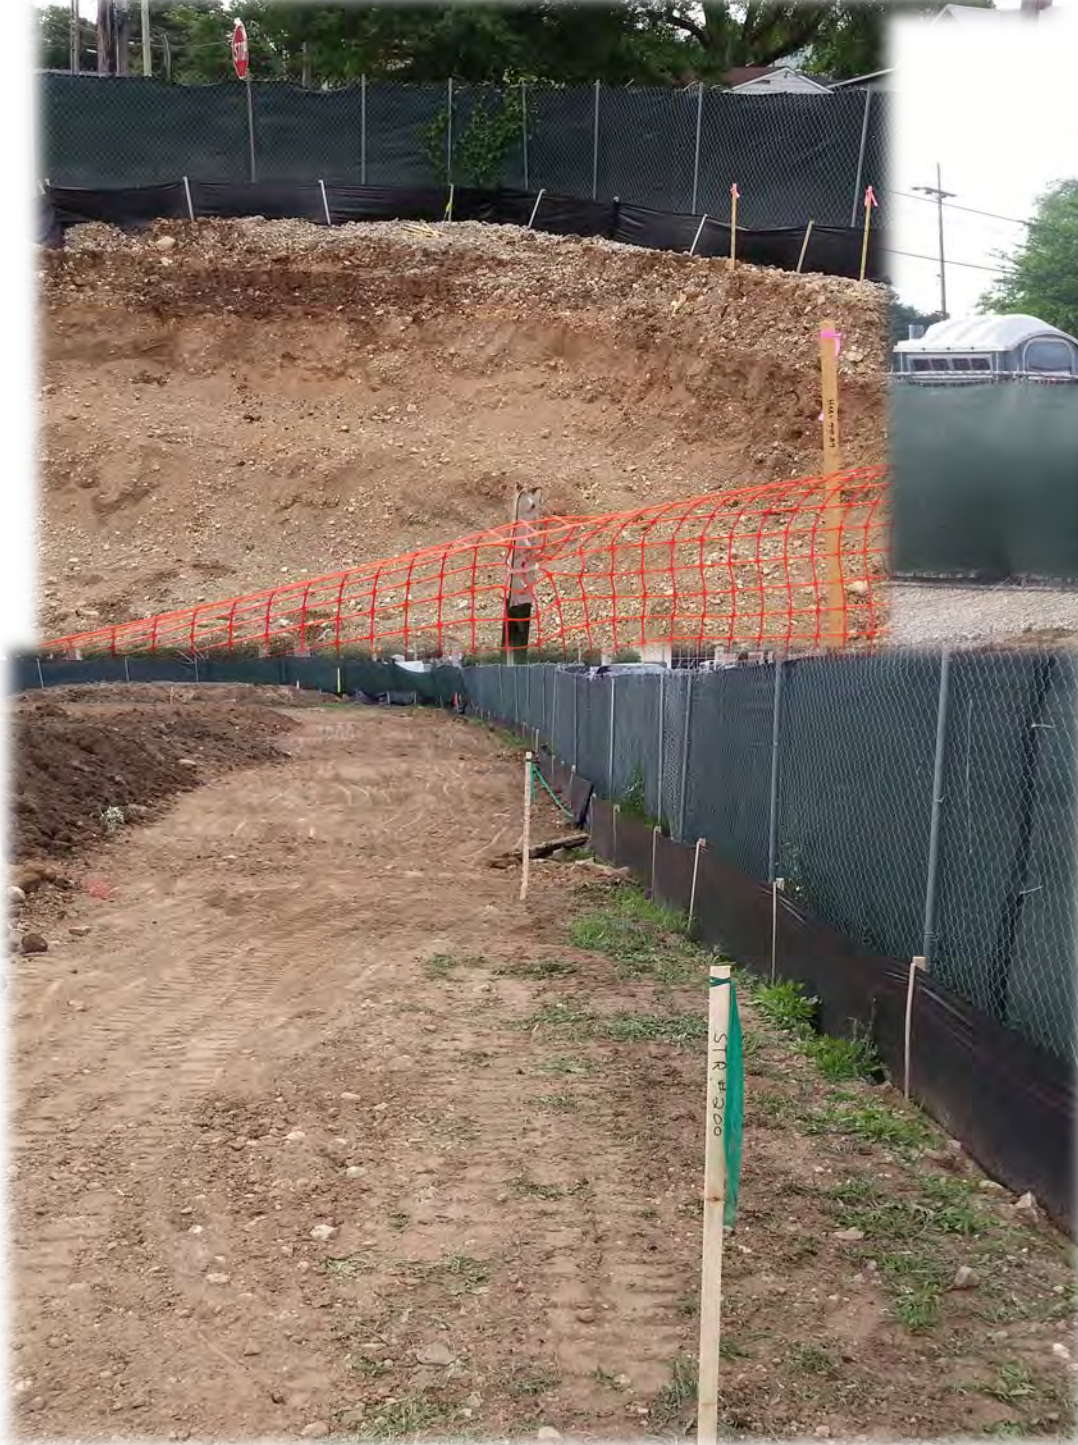
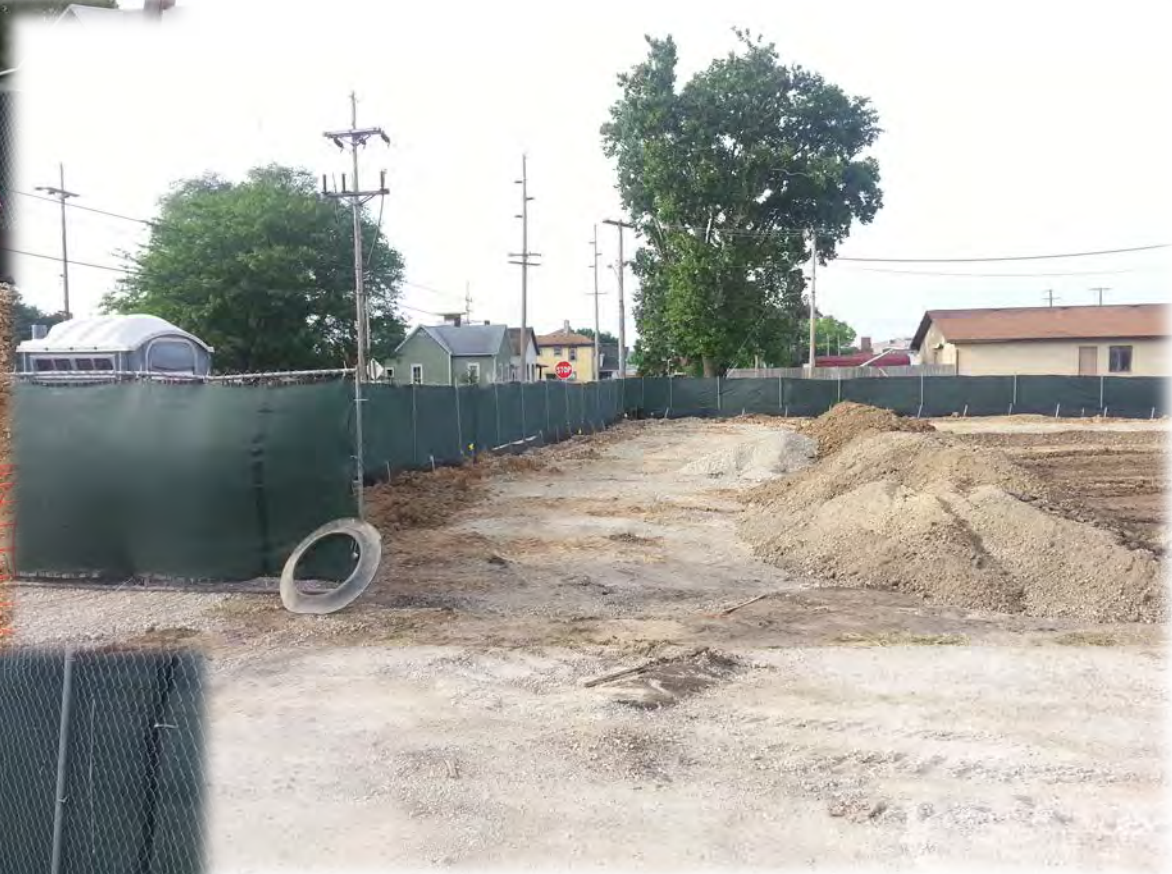
May 28, 2014

Demolition

- *Perimeter Protection*

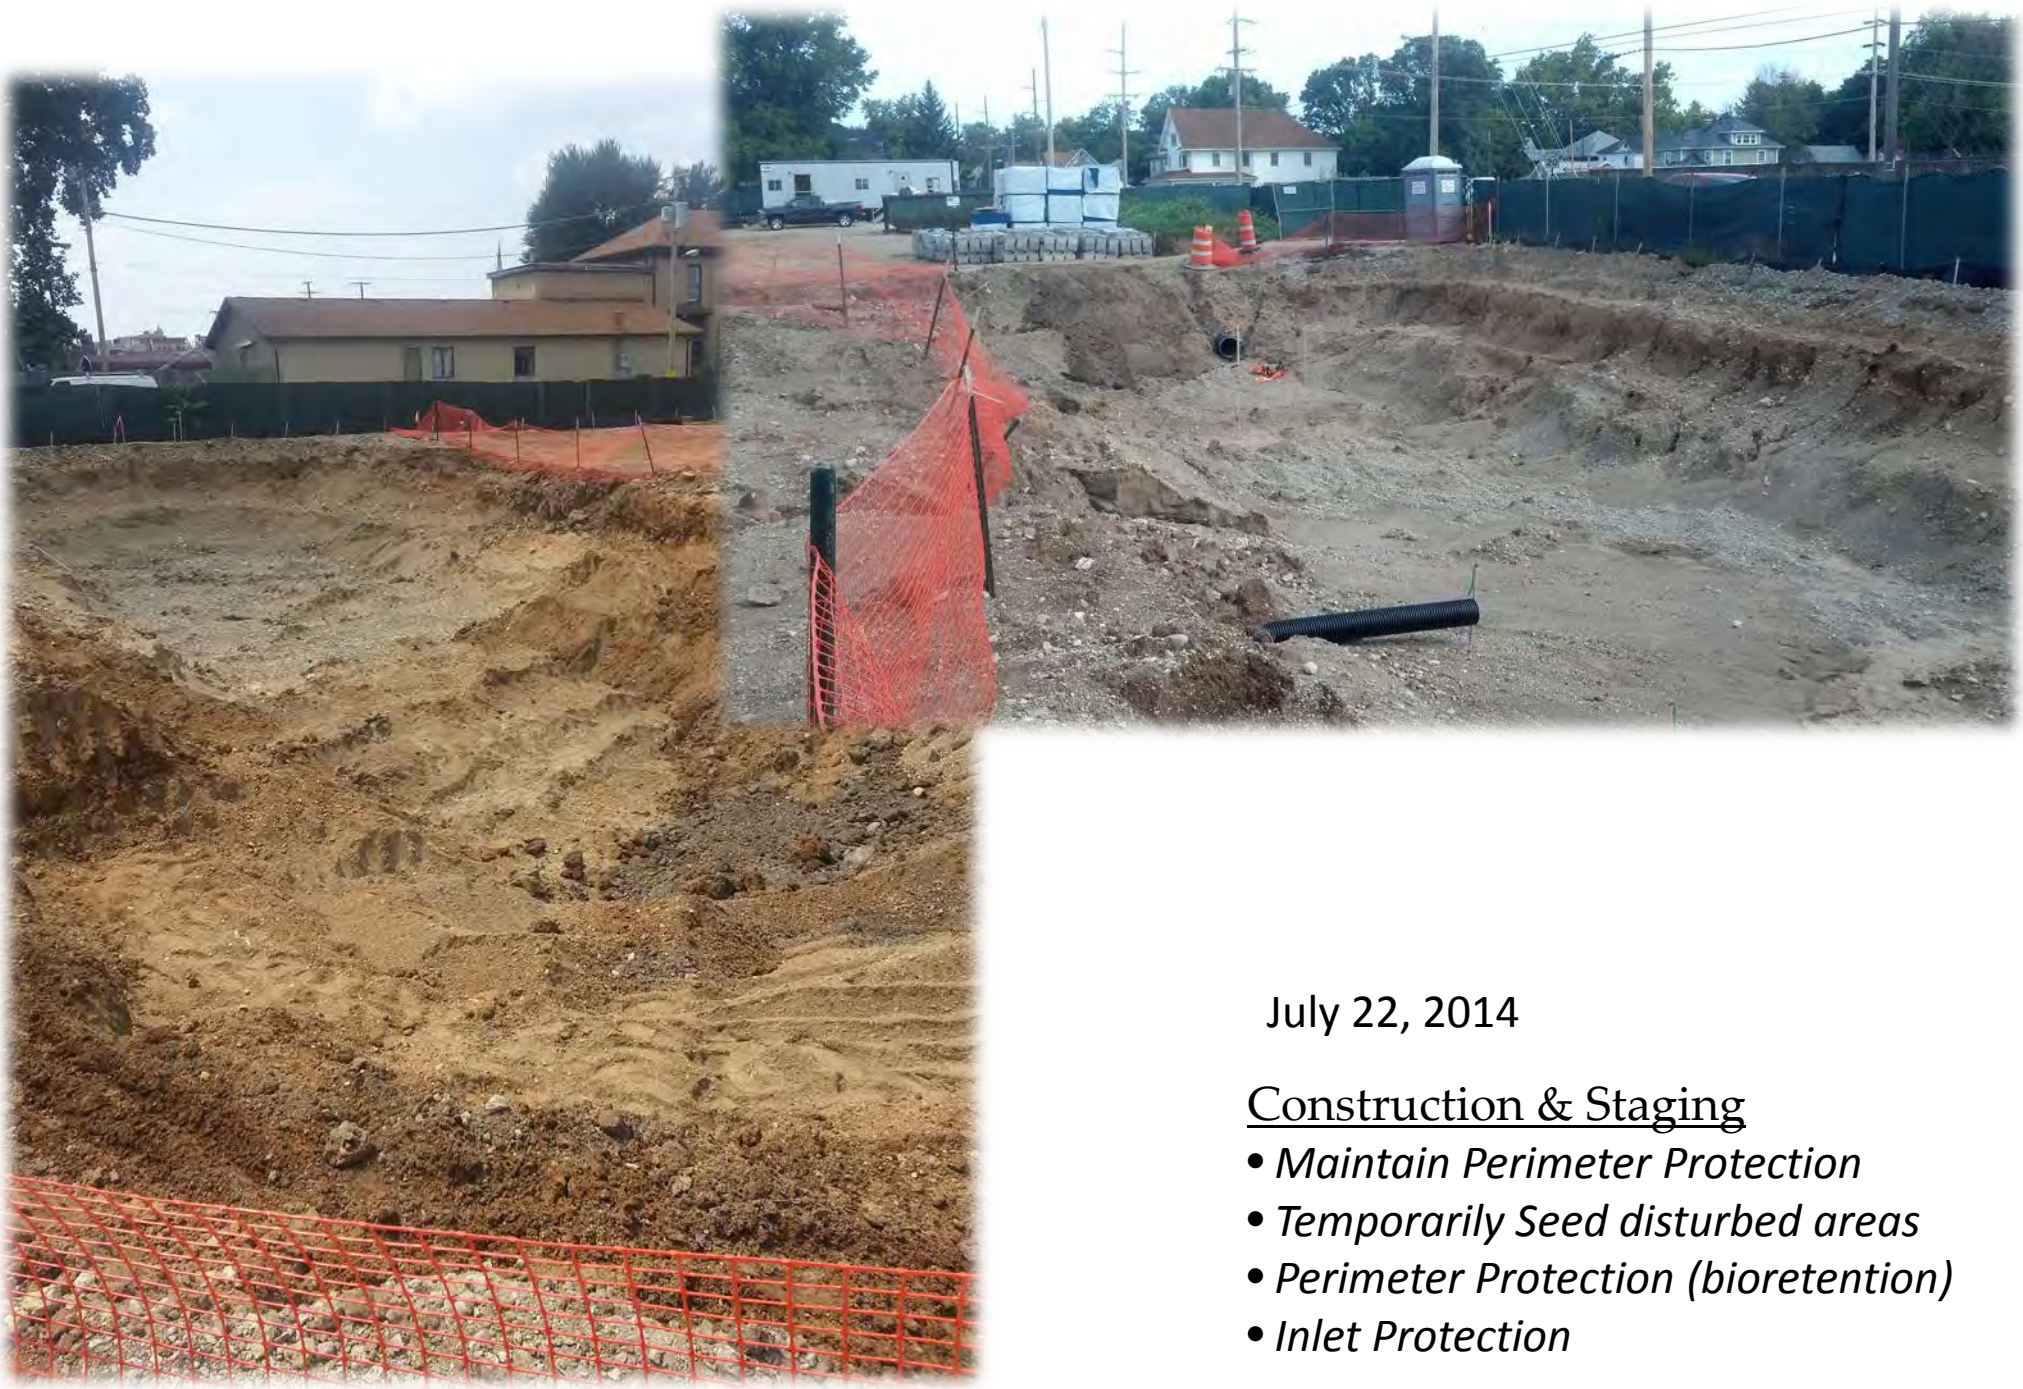
June 18, 2014

Construction & Staging

- *Maintain Perimeter Protection*
- *Temporarily Seed disturbed areas*
- *Perimeter Protection (bioretention)*
- *Inlet Protection*

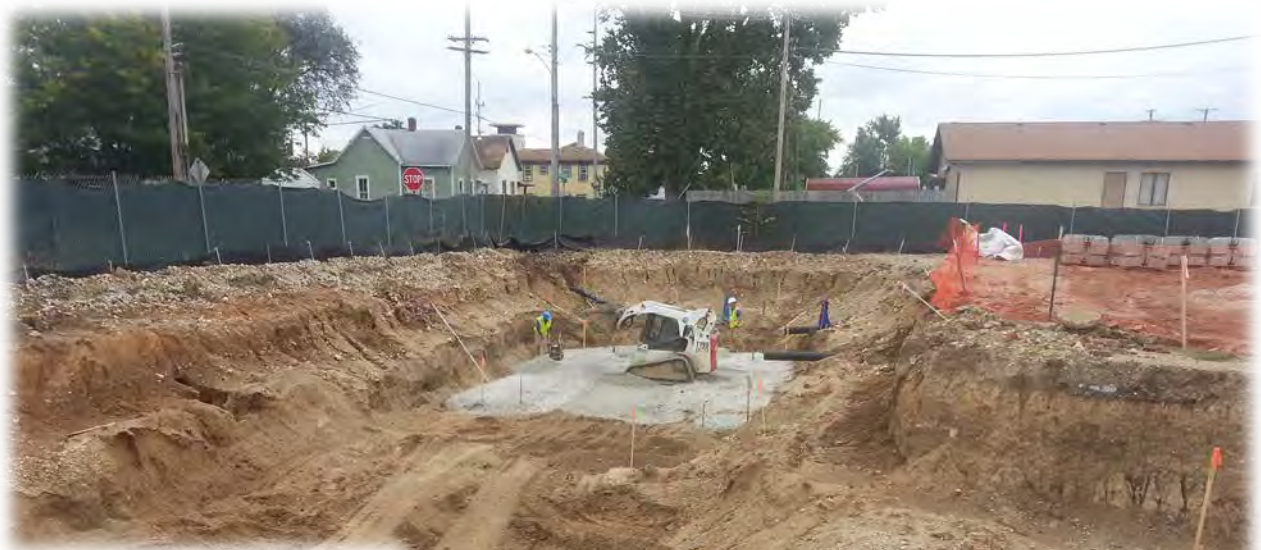
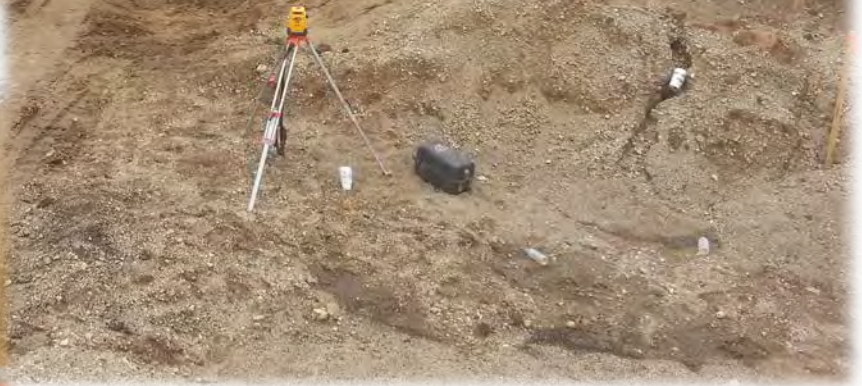
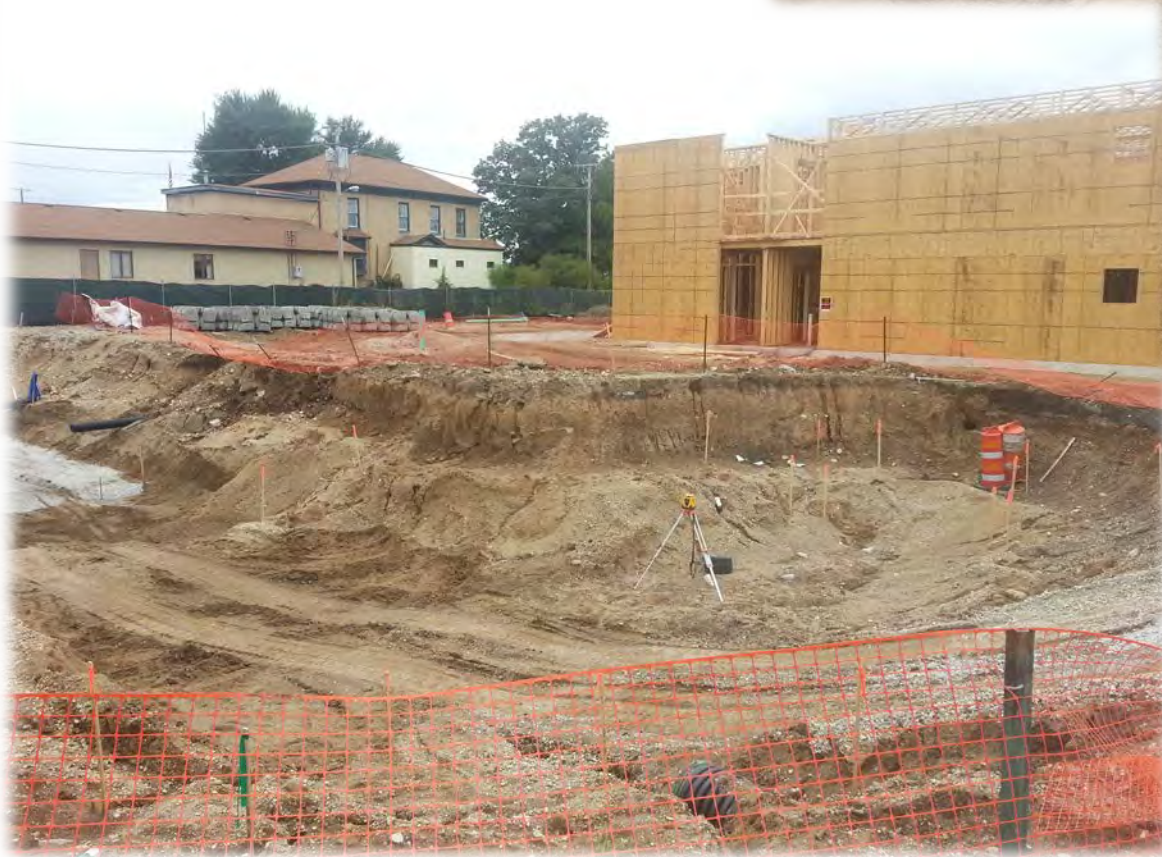
July 22, 2014

Construction & Staging

- *Maintain Perimeter Protection*
- *Temporarily Seed disturbed areas*
- *Perimeter Protection (bioretention)*
- *Inlet Protection*

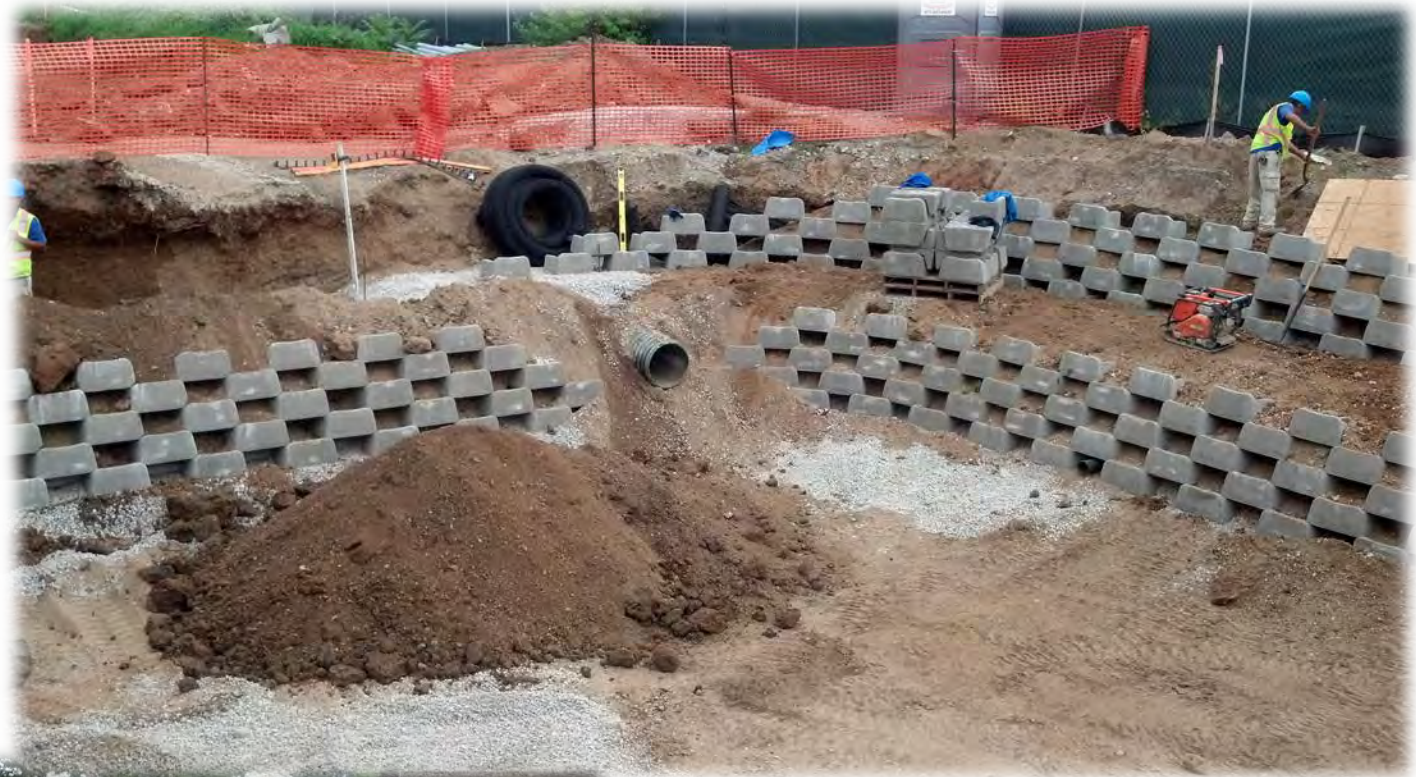
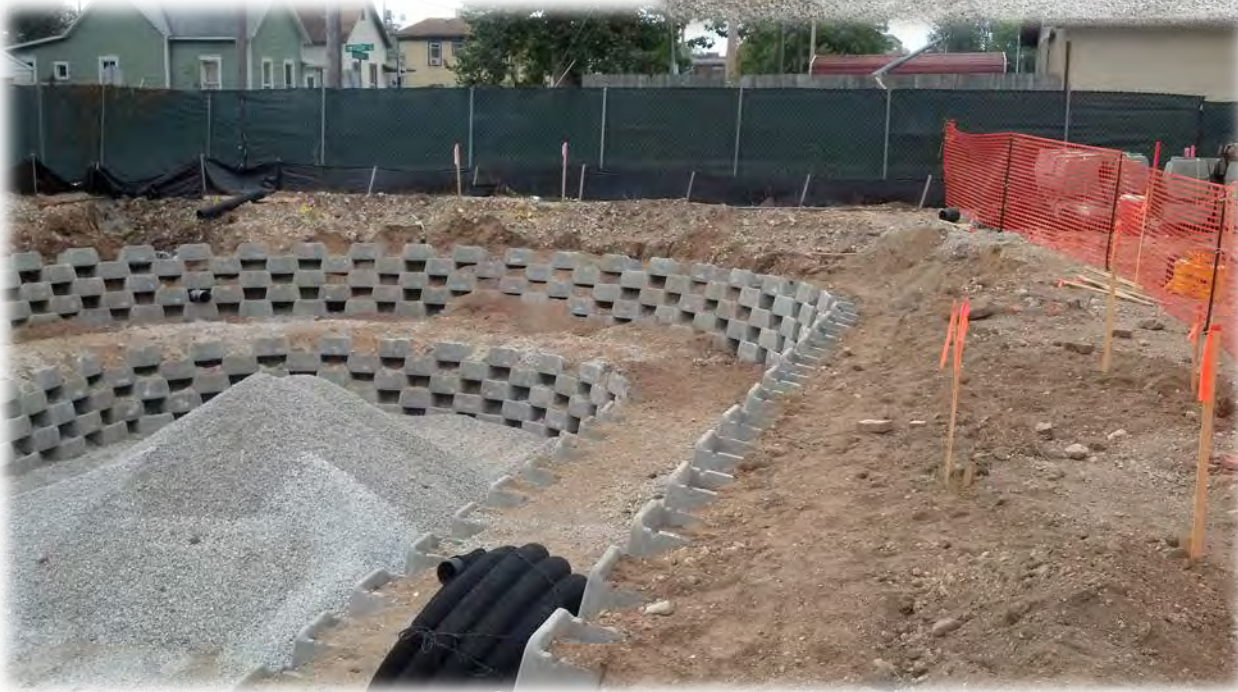
Sept. 16, 2014

Construction & Staging

- *Maintain Perimeter Protection*
- *Temporarily Seed disturbed areas*
- *Perimeter Protection (bioretention)*
- *Inlet Protection*

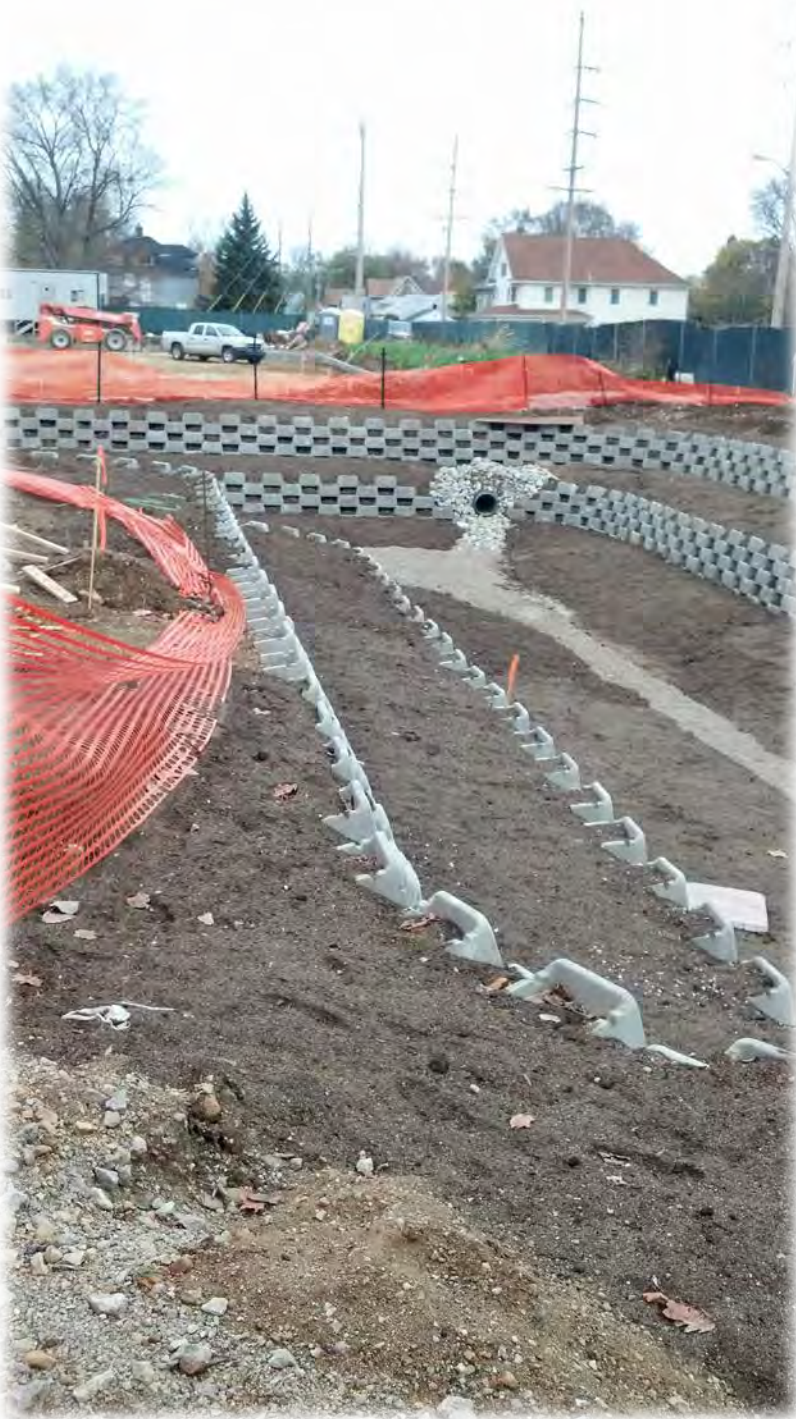
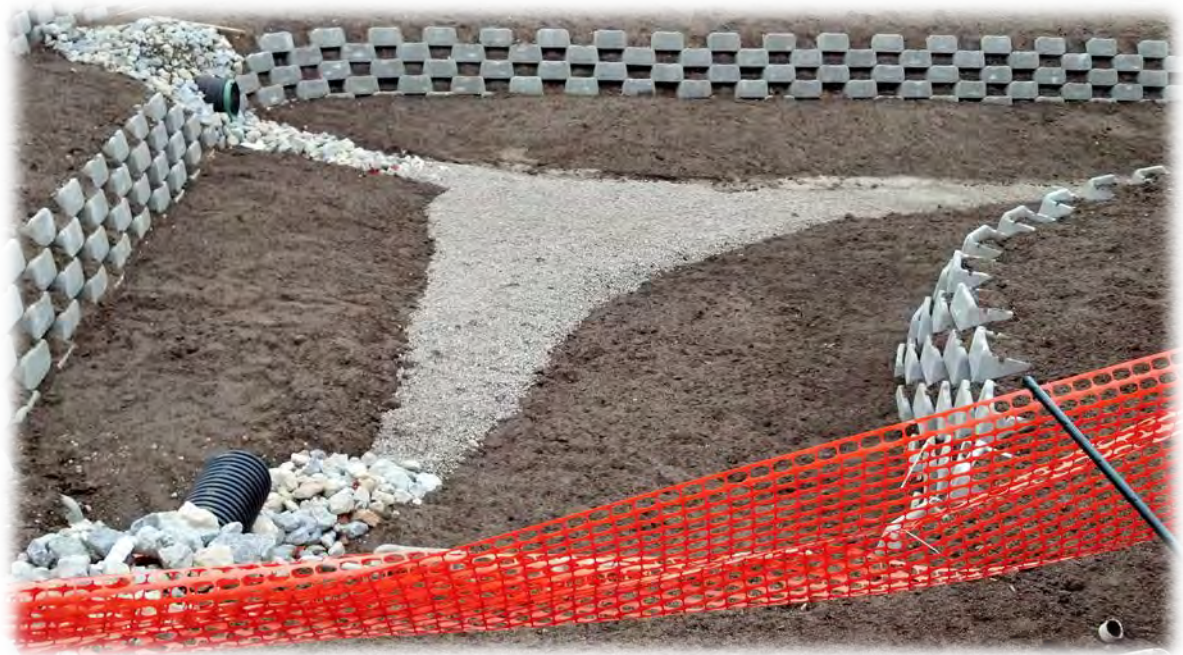
Oct. 2, 2014

Construction & Staging

- *Maintain Perimeter Protection*
- *Temporarily Seed disturbed areas*
- *Perimeter Protection (bioretention)*
- *Inlet Protection*

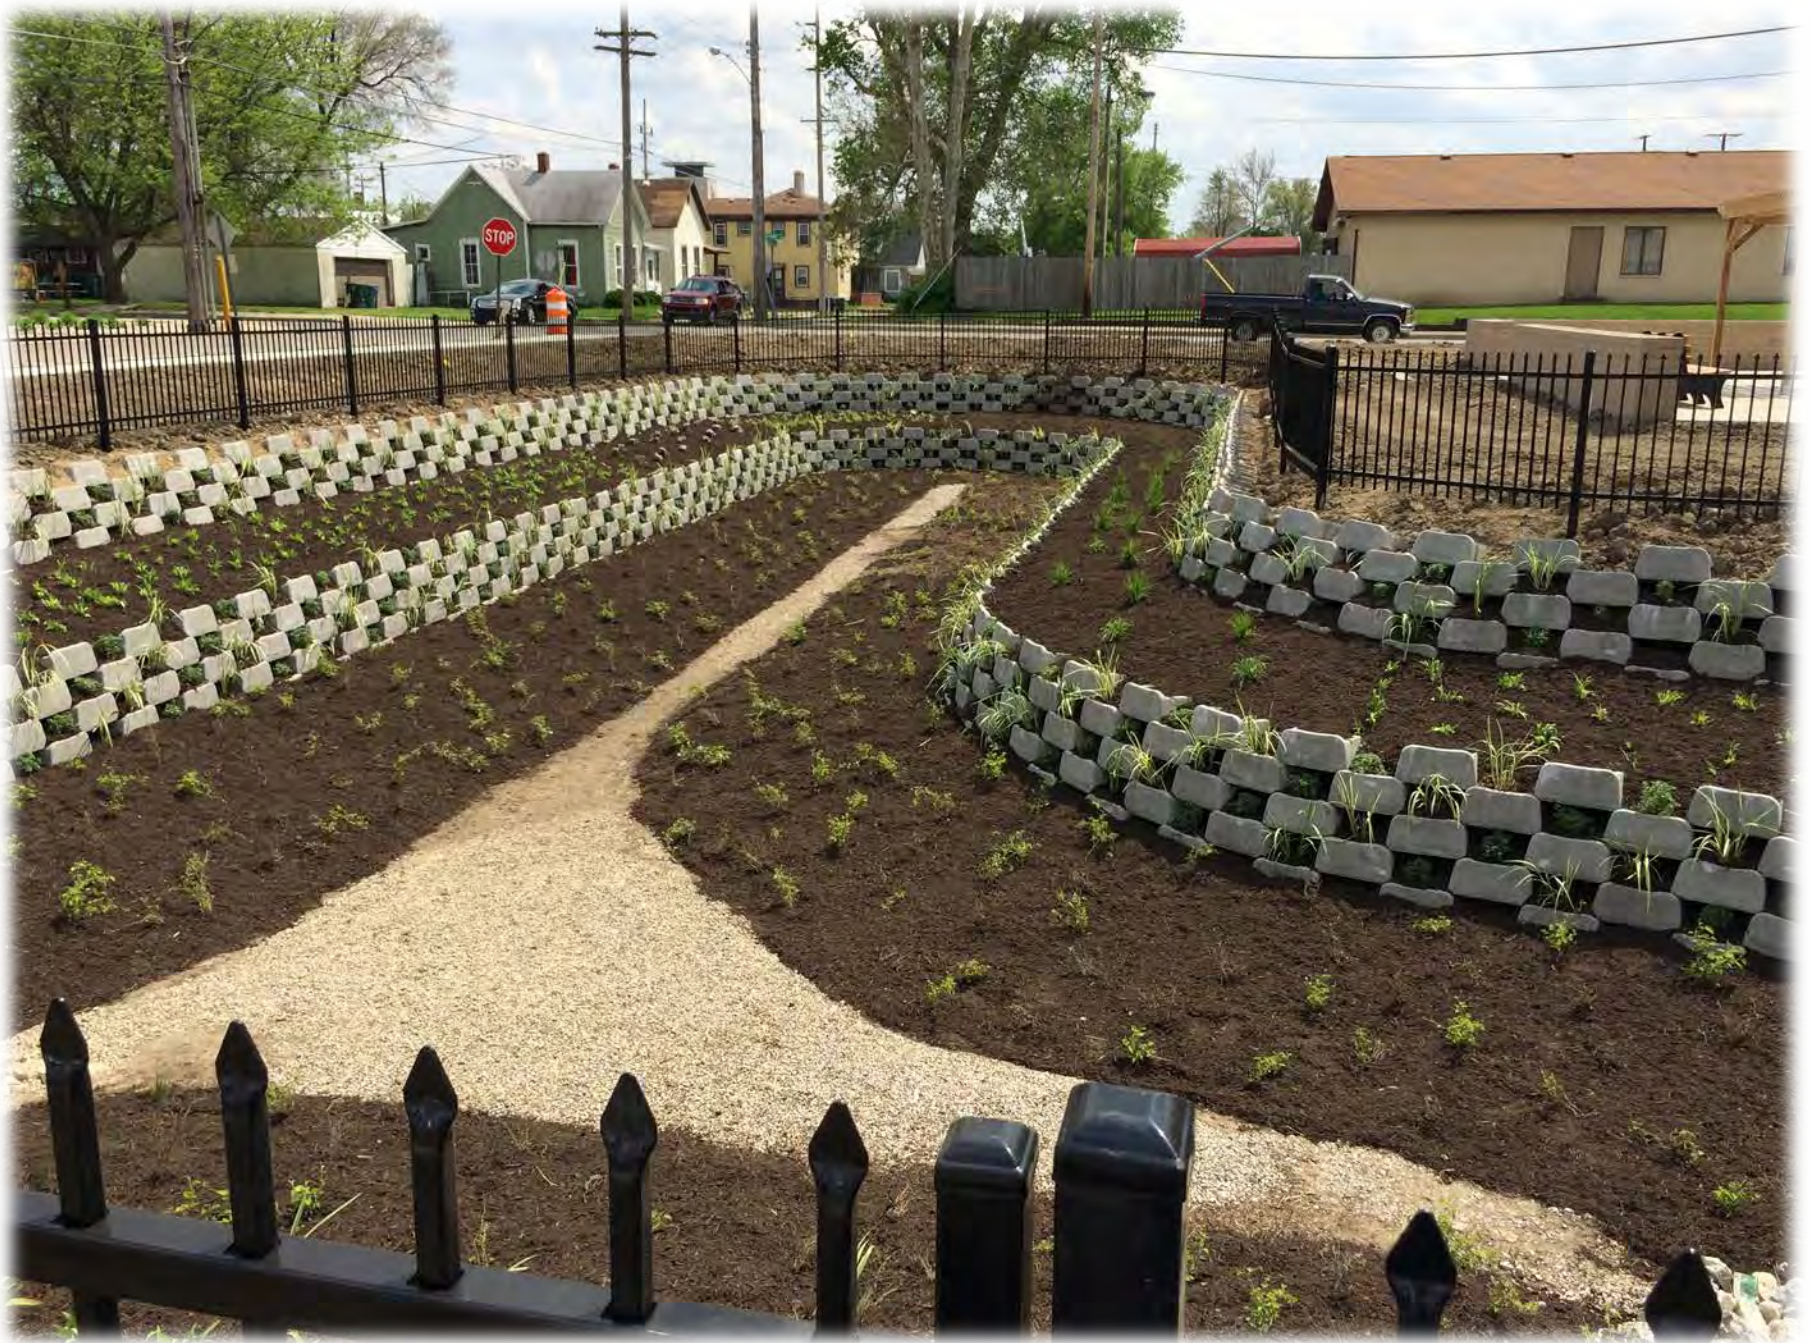
Nov. 7, 2014

Construction & Staging

- *Maintain Perimeter Protection*
- *Temporarily Seed disturbed areas*
- *Perimeter Protection (bioretention)*
- *Inlet Protection*

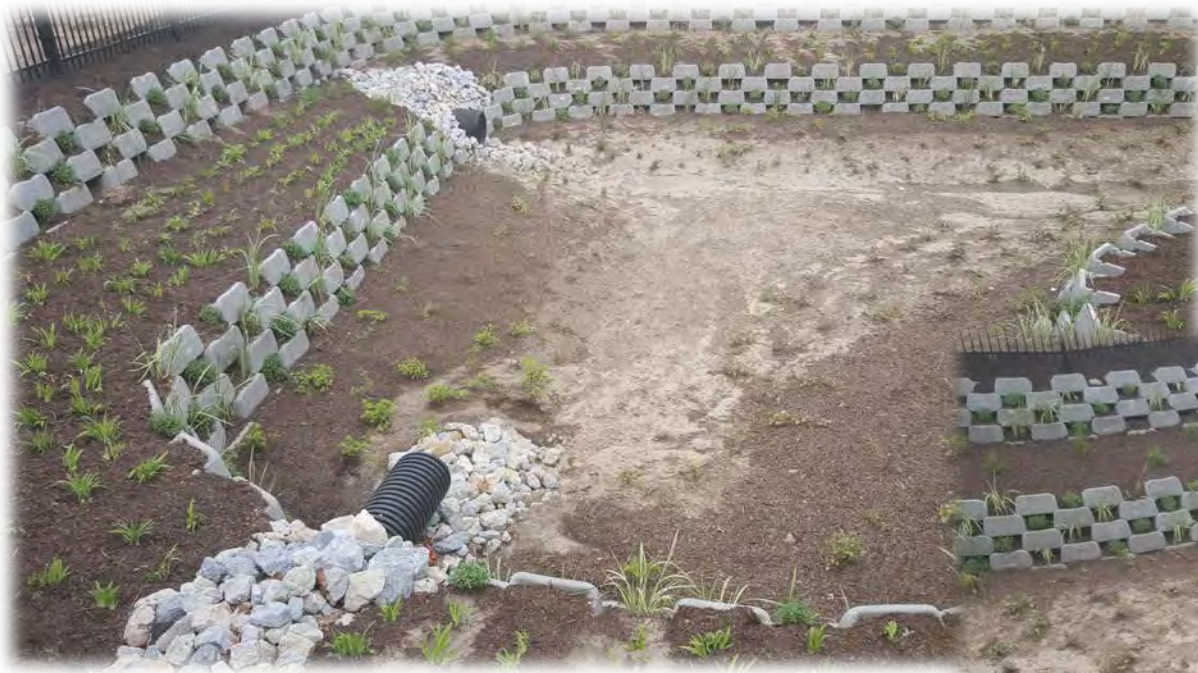
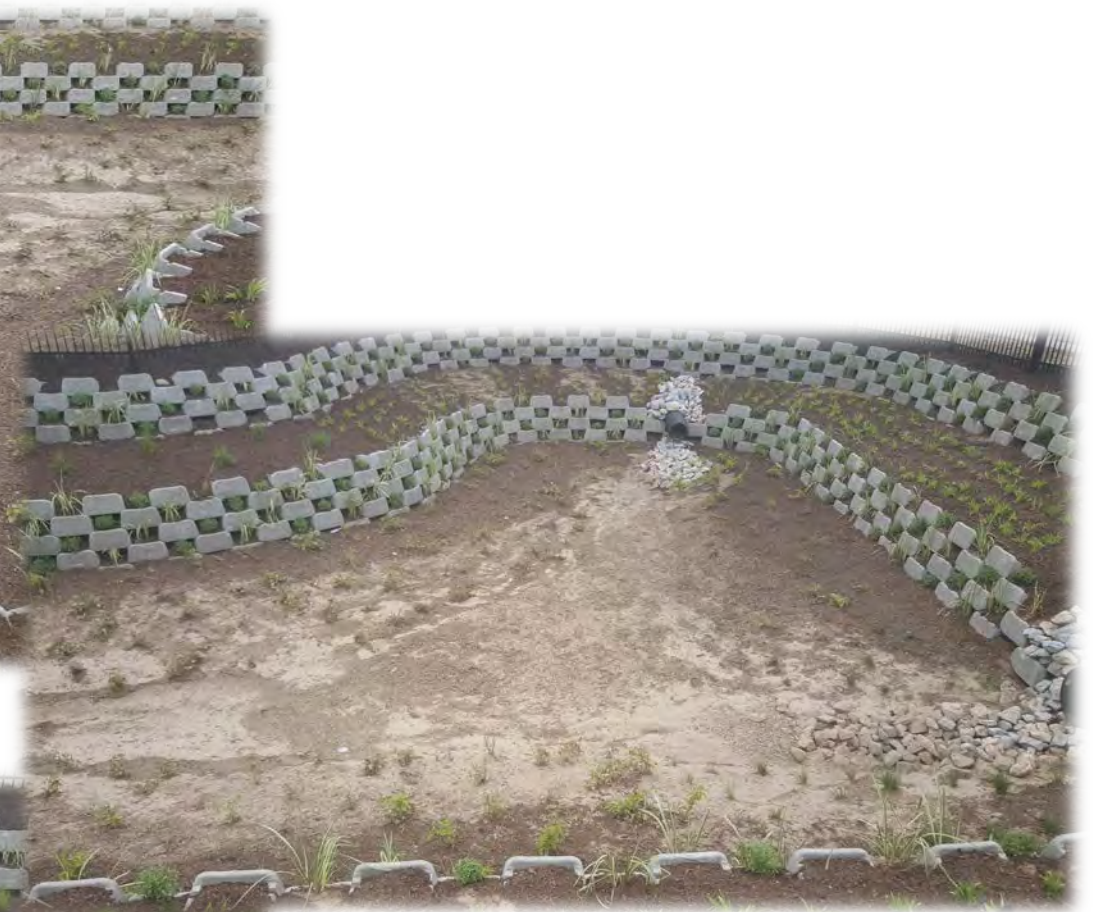
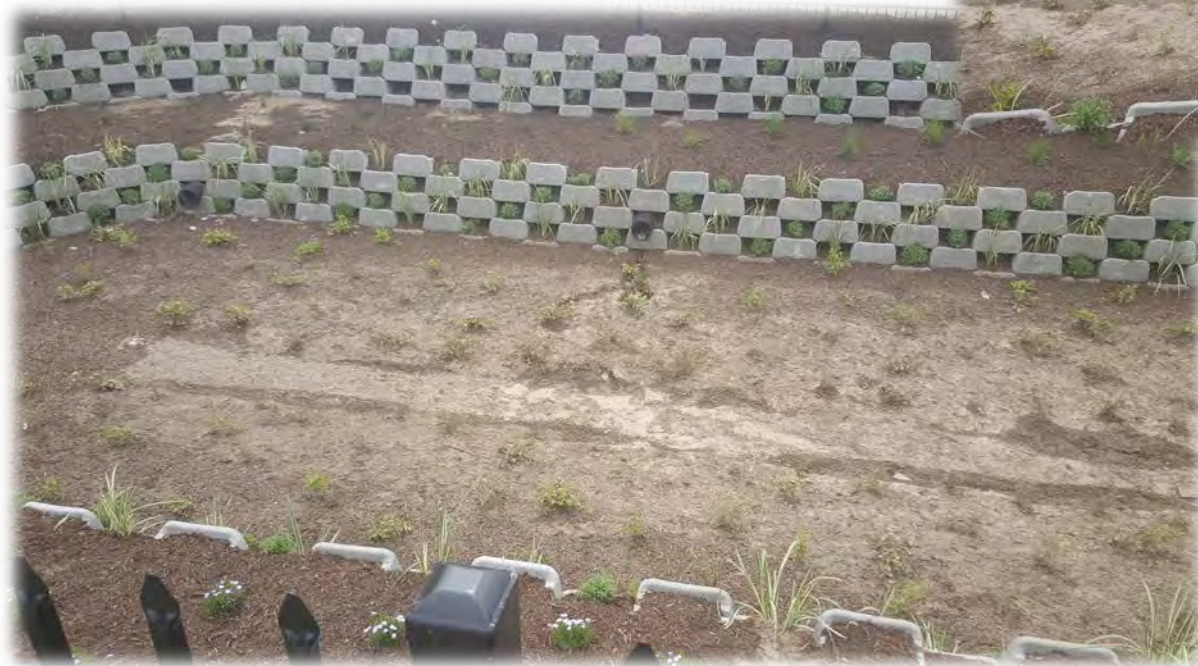
May 14, 2015

Post-Construction

- *Maintain BMPs until NOT*
