Designer and Reviewer Roles and Importance in Stormwater Management: A Case Study

Walnut Commons

500 N. Walnut Street
Muncie, Indiana

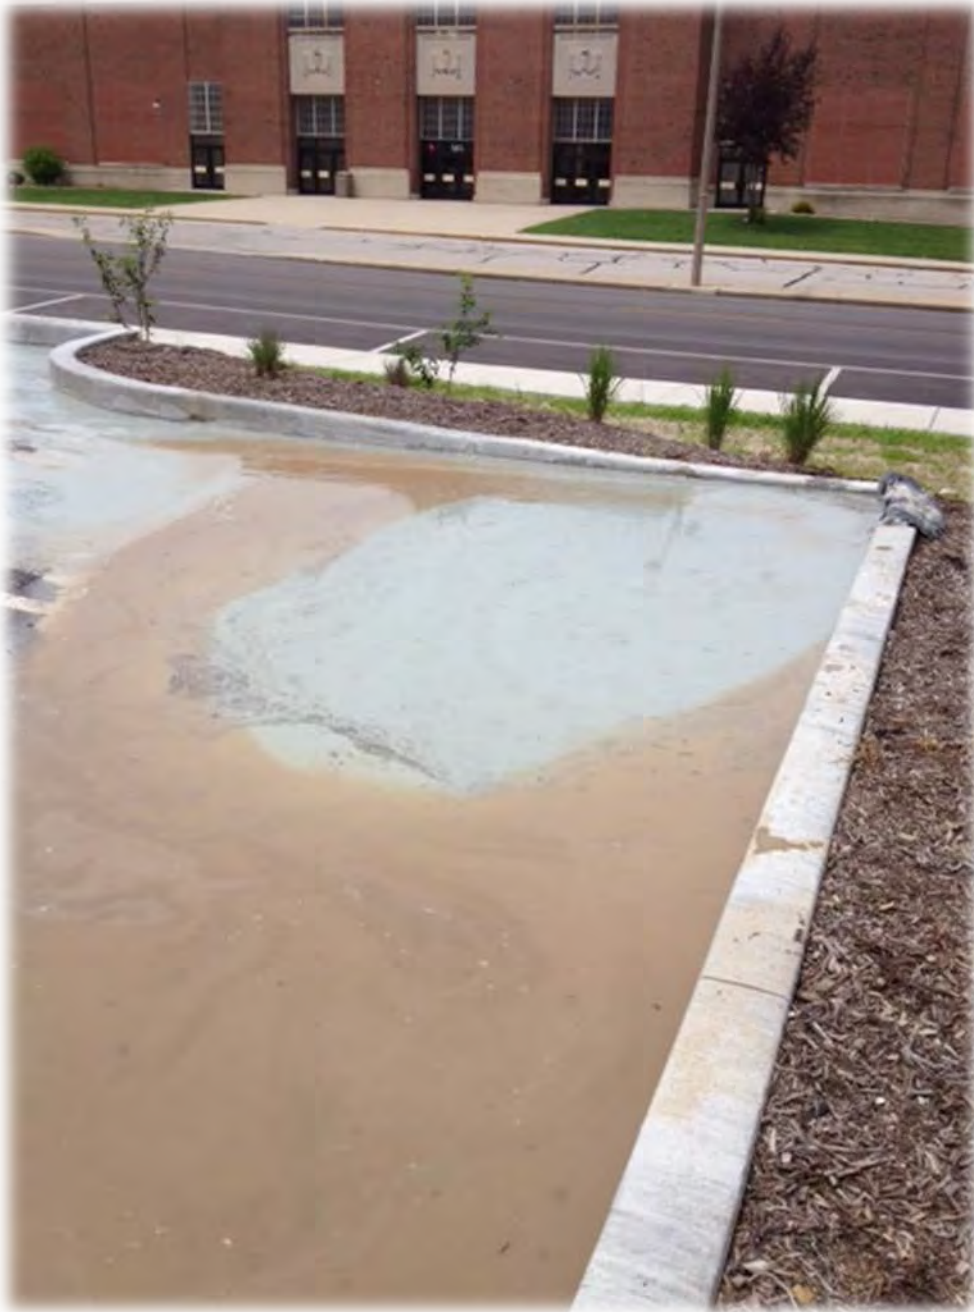
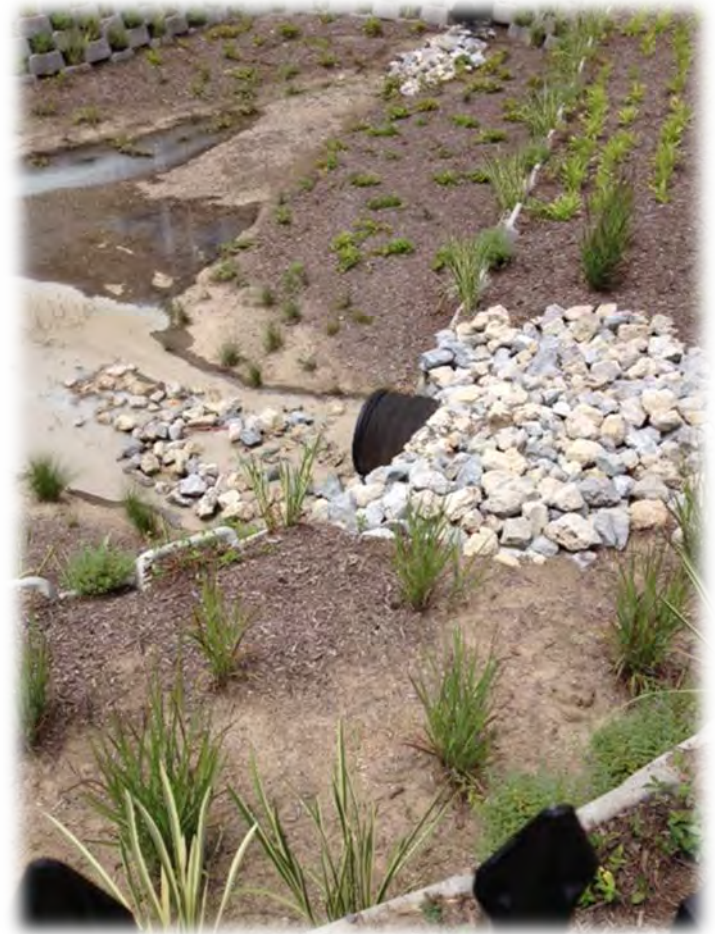
May 14, 2015

Post-Construction

- *Maintain BMPs until NOT*

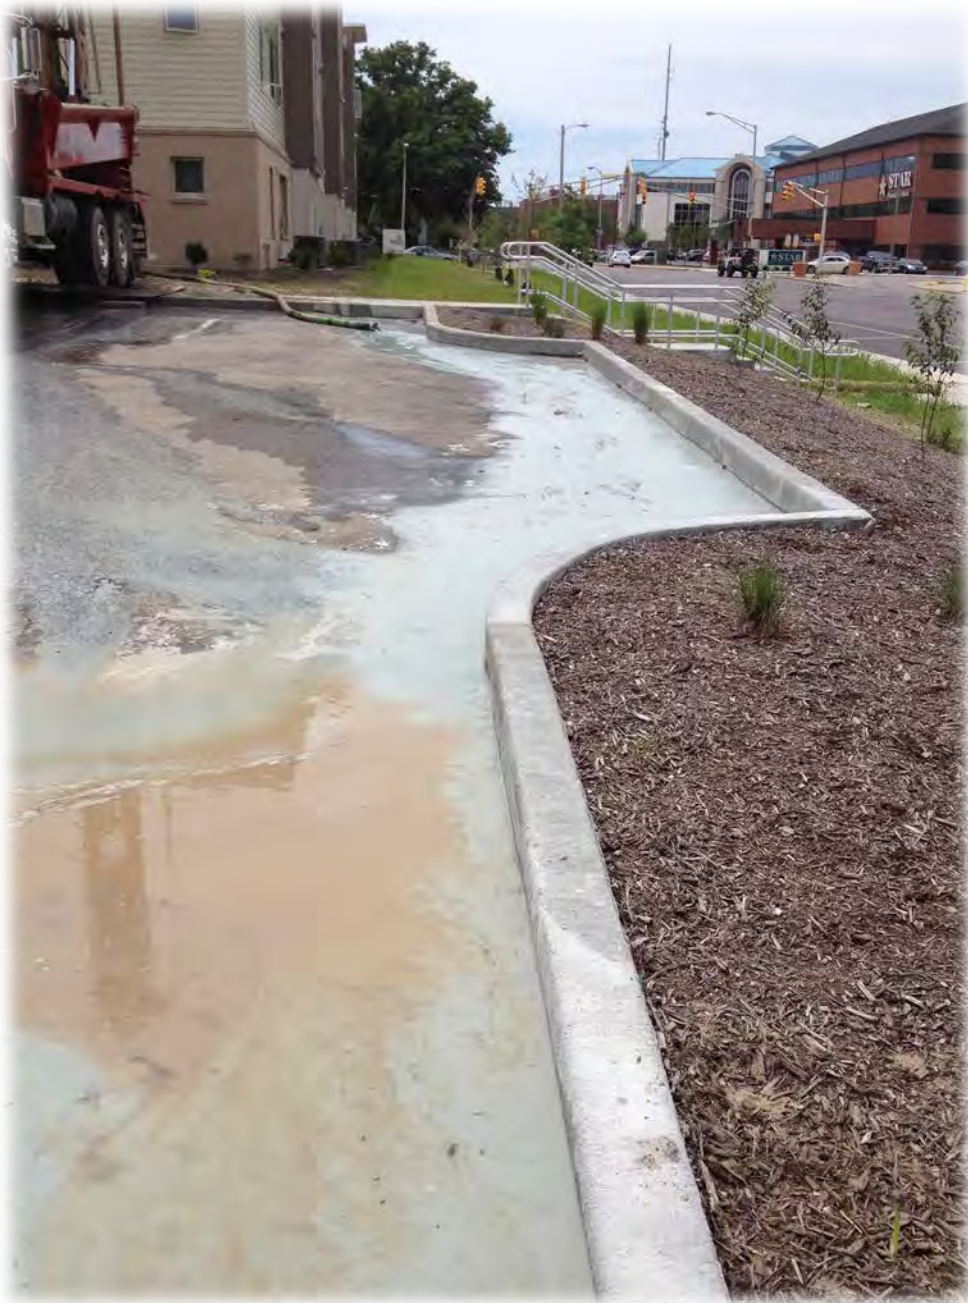
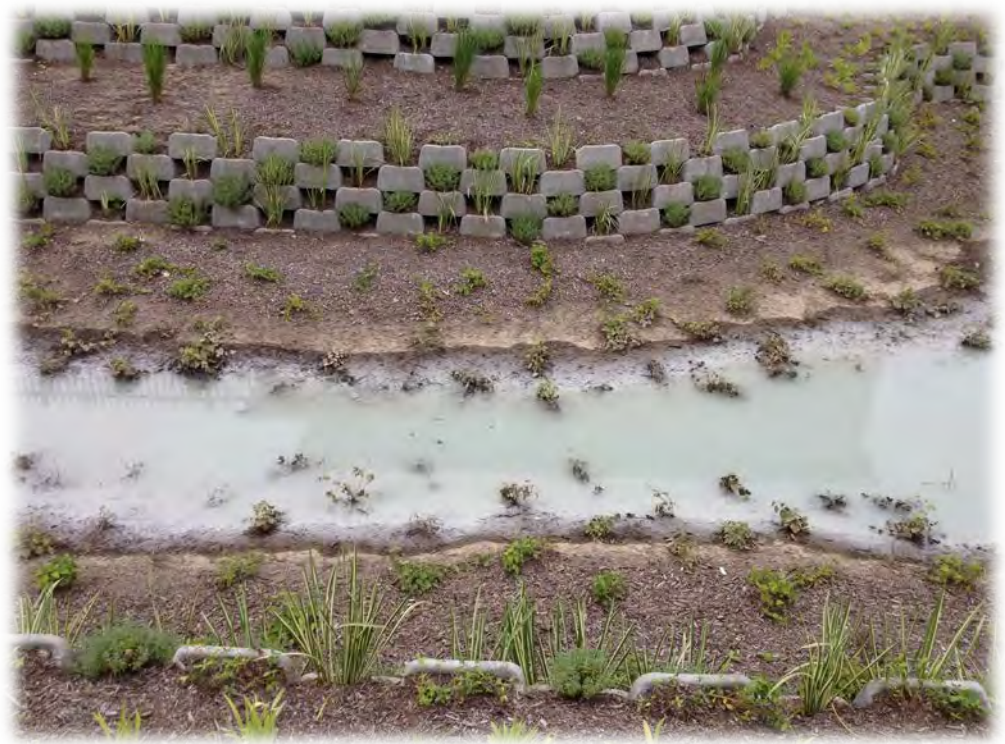
June 24, 2015

Post-Construction

- *Drilling of Well for Irrigation*
- ***STOP WORK ORDER ISSUED!***

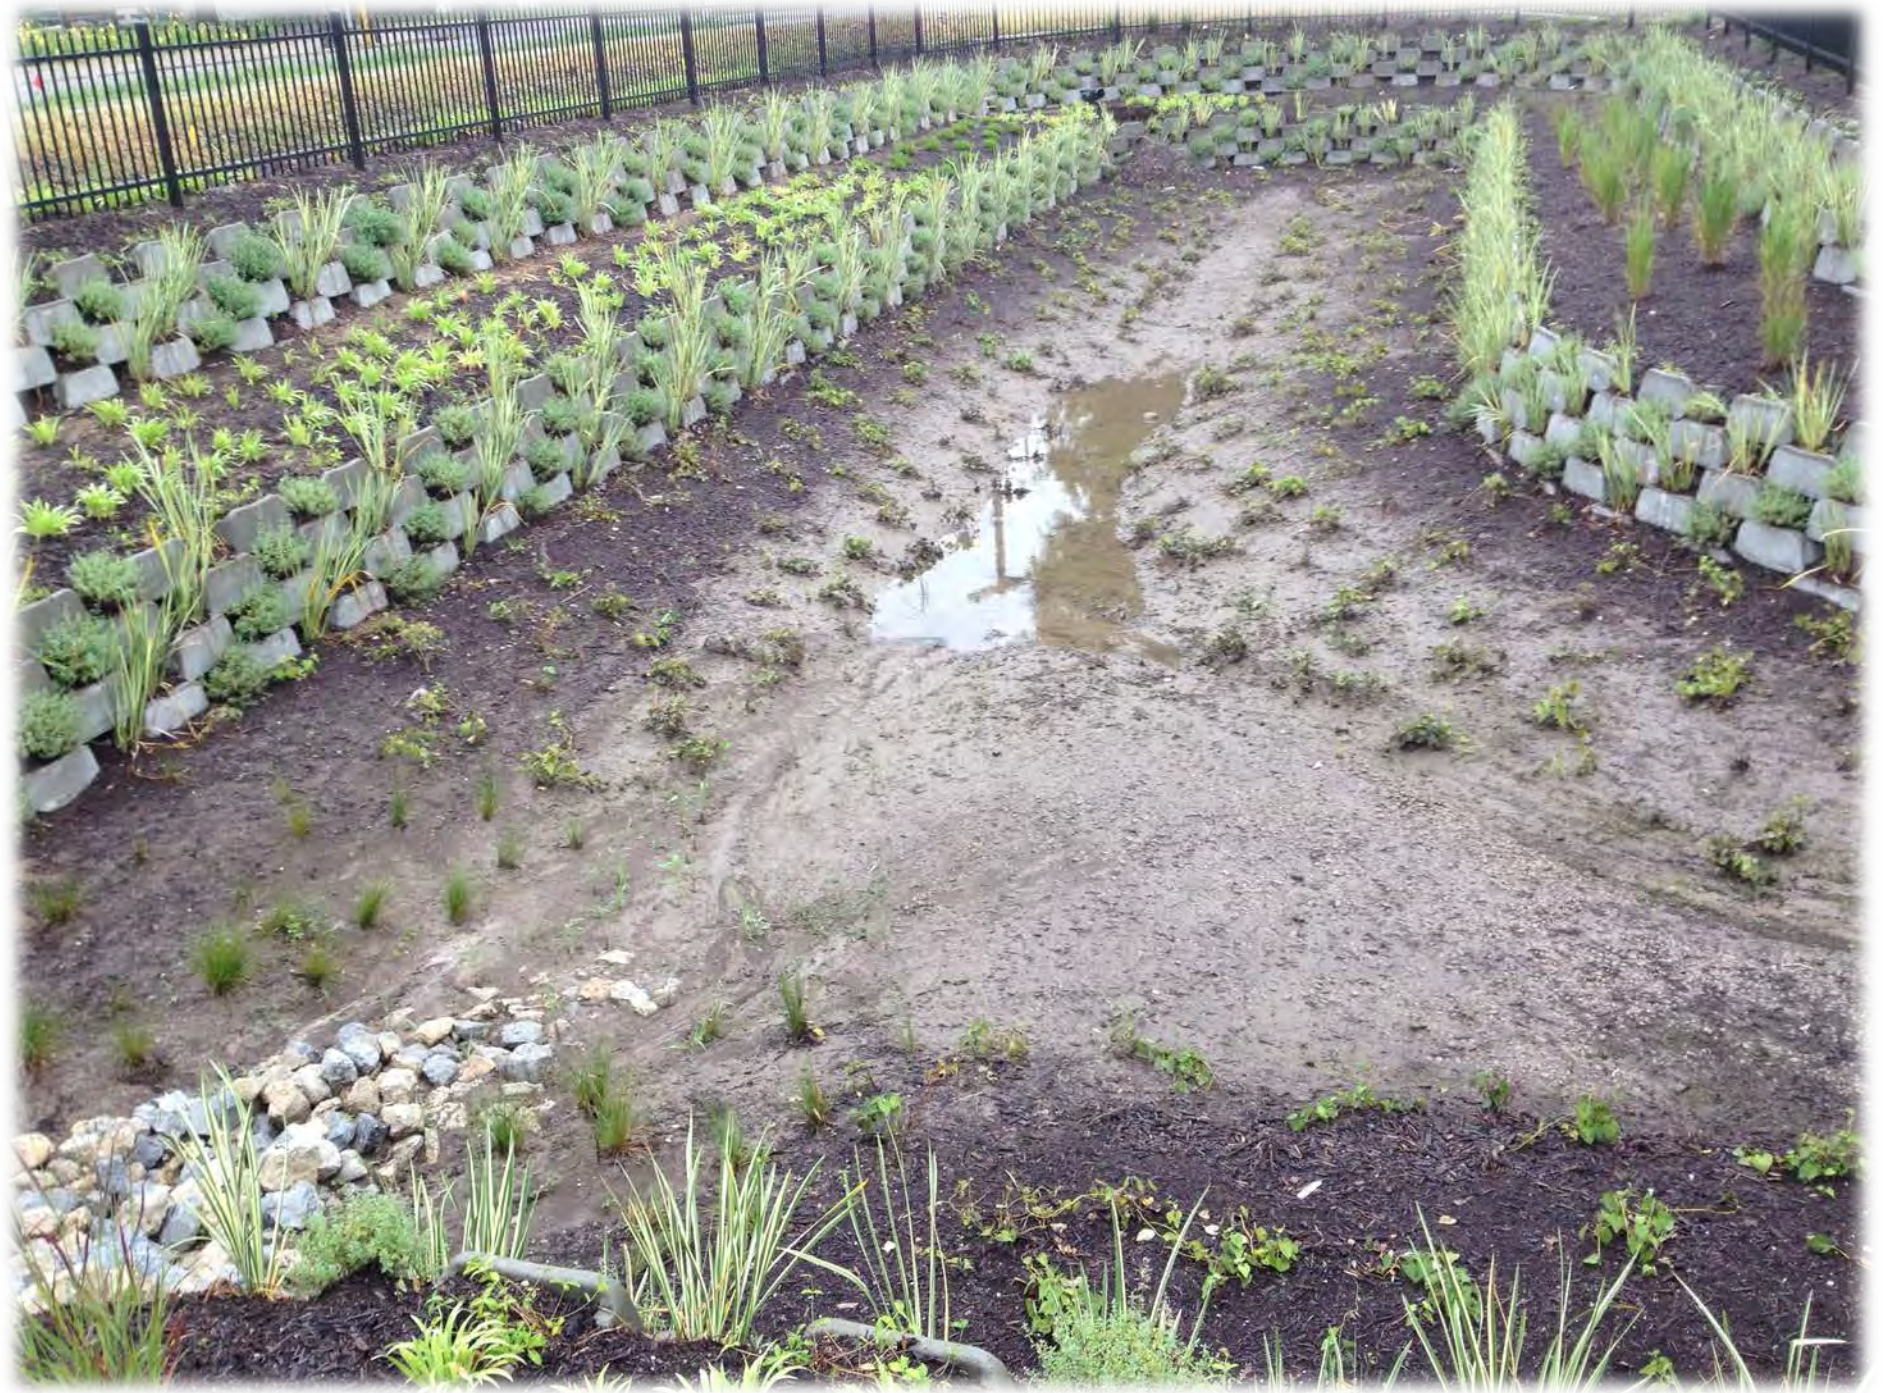
June 24, 2015

Post-Construction

- *Drilling of Well for Irrigation*
- ***STOP WORK ORDER ISSUED!***

1. Remove accumulated sediment from around inlets and haul offsite
2. Clean debris from storm sewer, structures and pipes
3. Seed/Sod all disturbed areas to be lawn
4. Removal of all sediment, stone, and dead plants from bioretention basin
5. Replace stone in infiltration trench
6. Place new plants and mulch in bioretention basin

Remediation took approximately 2 weeks and cost in excess of \$20K!
